Issued November 2023

REPORT MARINE 2023/06

***Marine casualty involving the cruise ship
'Viking Polaris' south-east of Cape Horn,
29 November 2022***

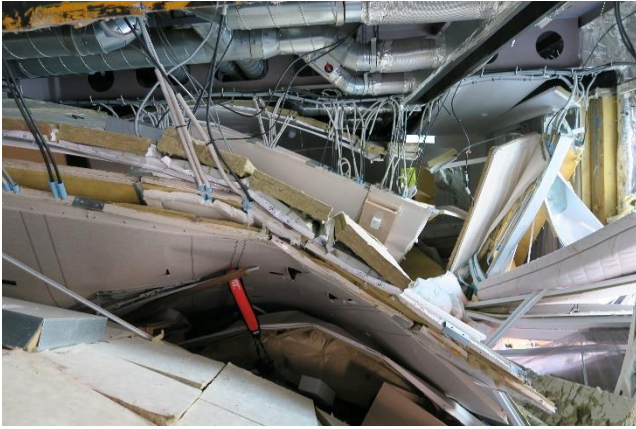
Figure 13: Photo from stateroom area showing damage to partition walls, floor and furnishings. Photo: NSIA

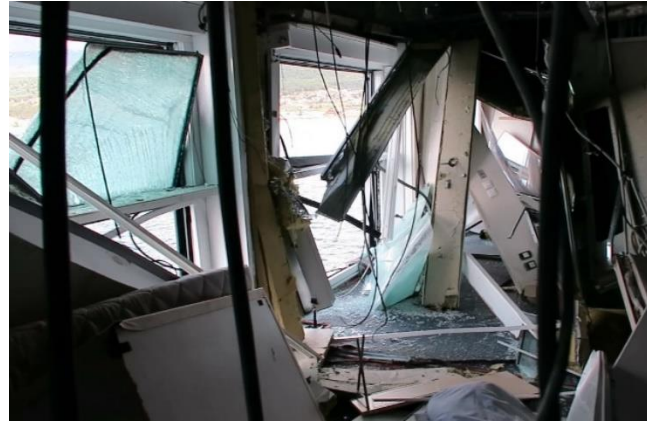
Figure 14: Broken windows in staterooms 2016 and 2014. Photo: NSIA

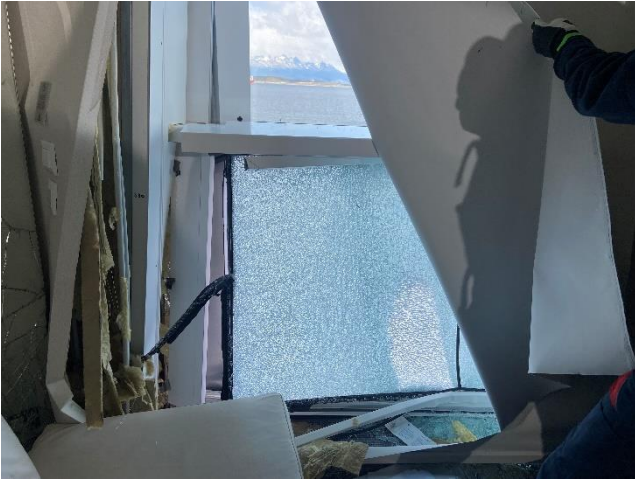
Figure 19: Damage to window and frame in stateroom 2008. Photo: NSIA

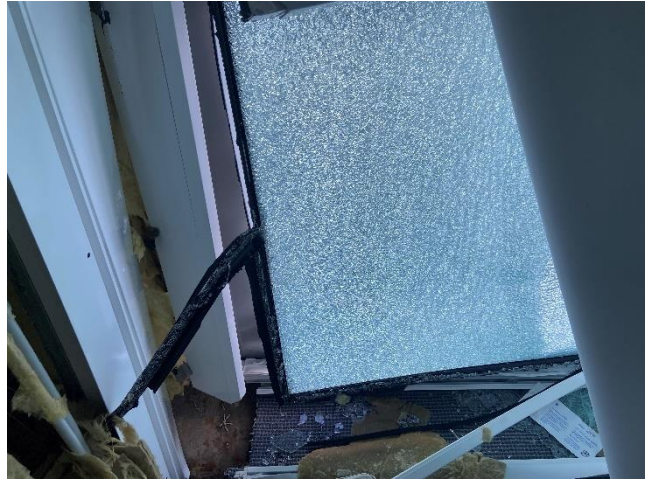
Figure 20: Damage to window and frame in stateroom 2008. Photo: NSIA

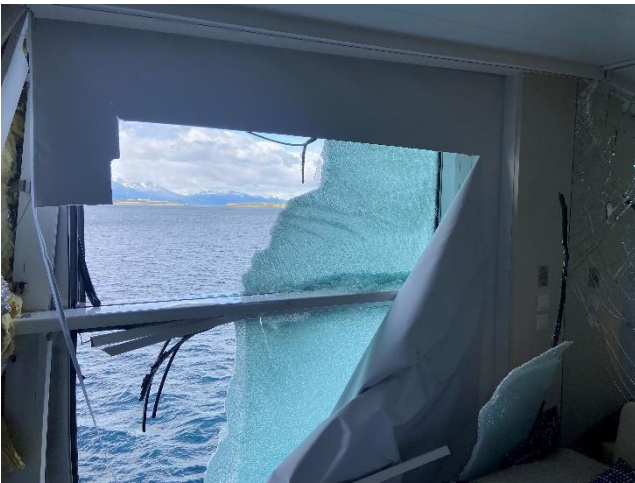
Figure 21: Damage to window and frame in stateroom 2010. Photo: NSIA

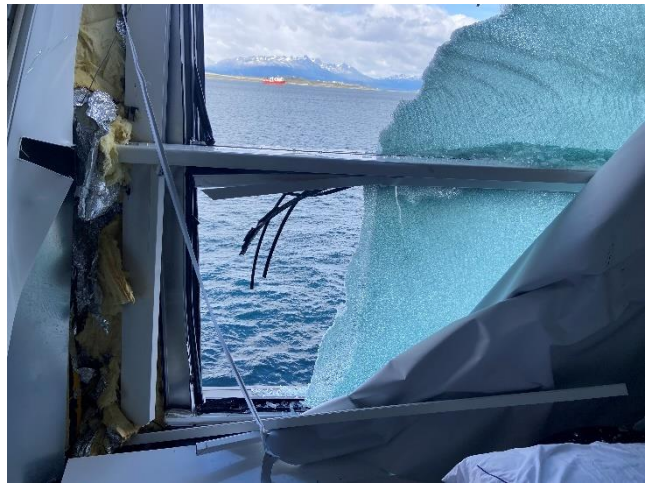
Figure 22: Damage to window and frame in stateroom 2010. Photo: NSIA

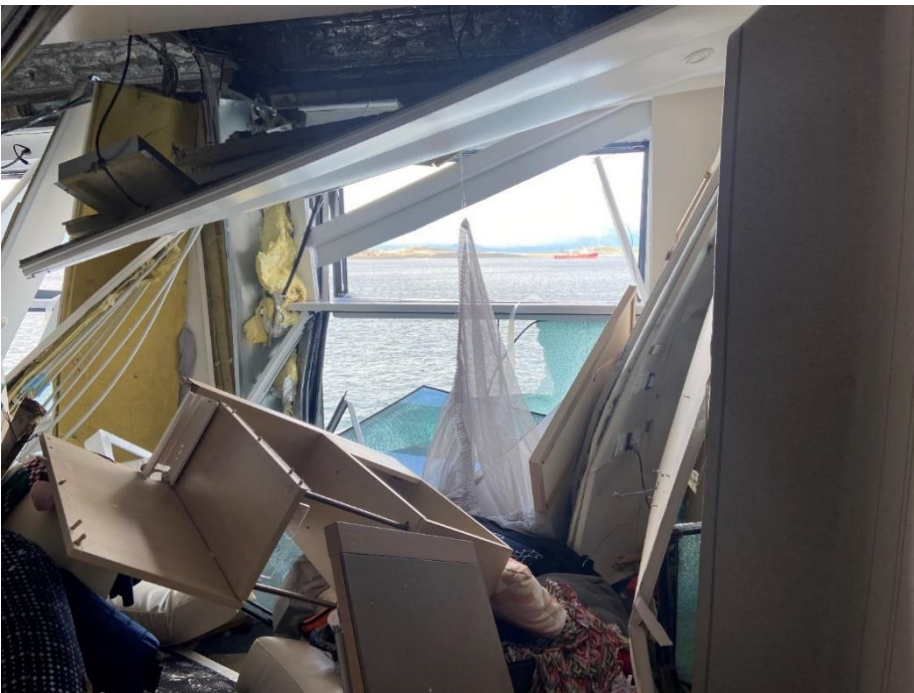
Figure 23: Damage to window, frame and stateroom 2012. Photo: NSIA

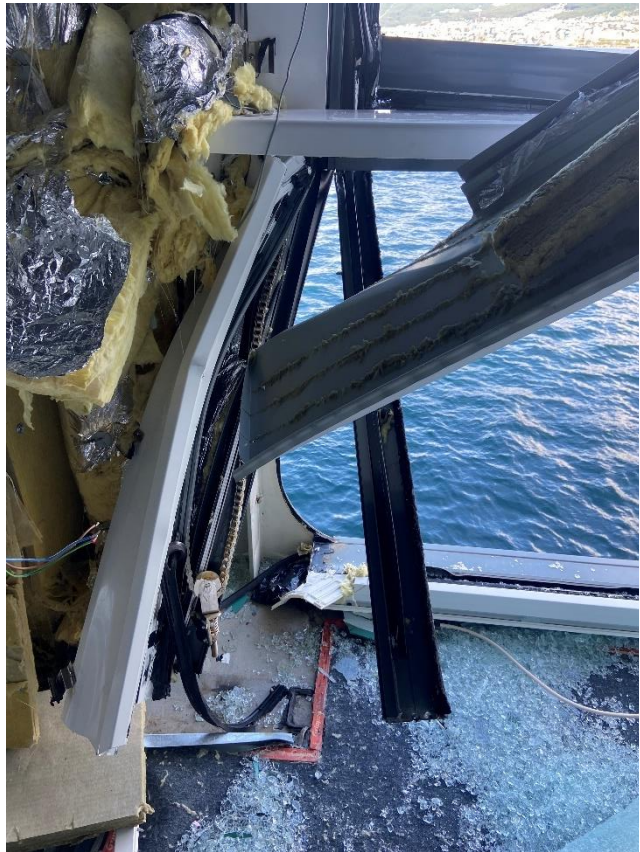
Figure 25: Damaged window frame in stateroom 2014. Photo: NSIA

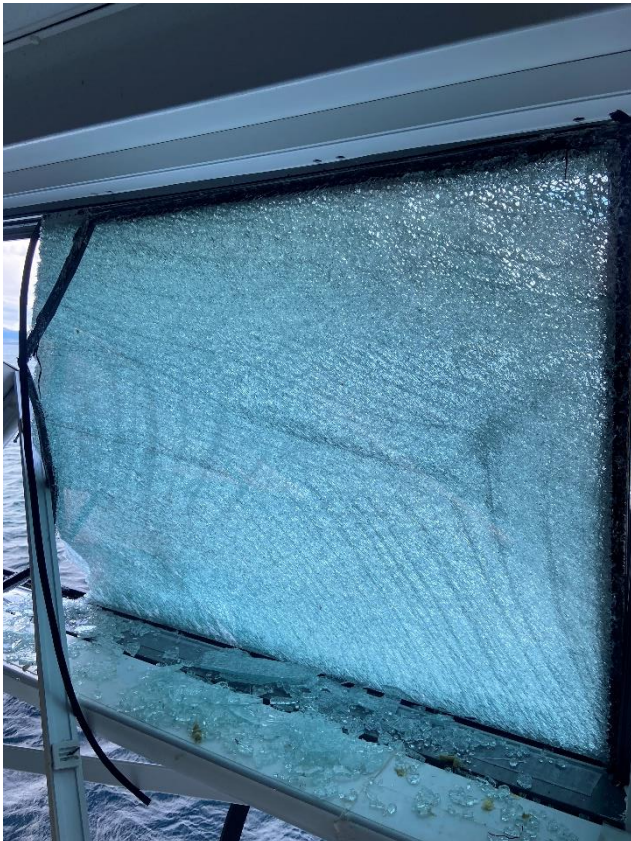
Figure 26: Broken window in stateroom 2016.
Photo: NSIA

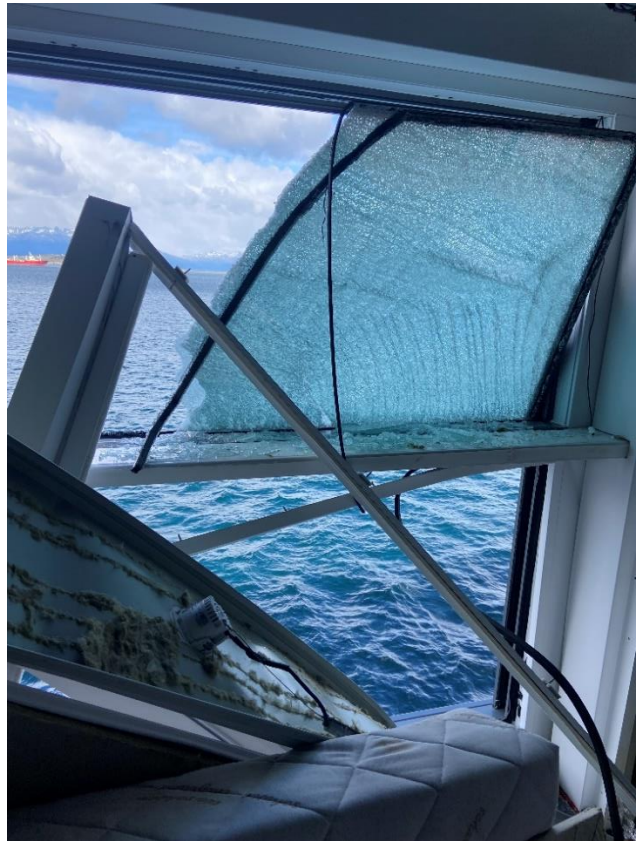
Figure 27: Broken window in stateroom 2016.
Photo: NSIA

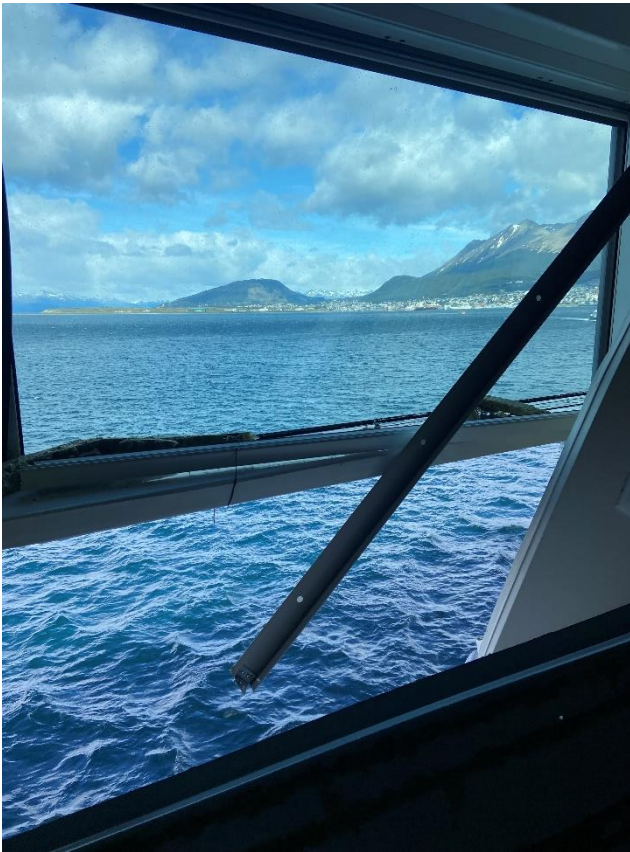
Figure 28: Damage to window in stateroom 2018.
Photo: NSIA

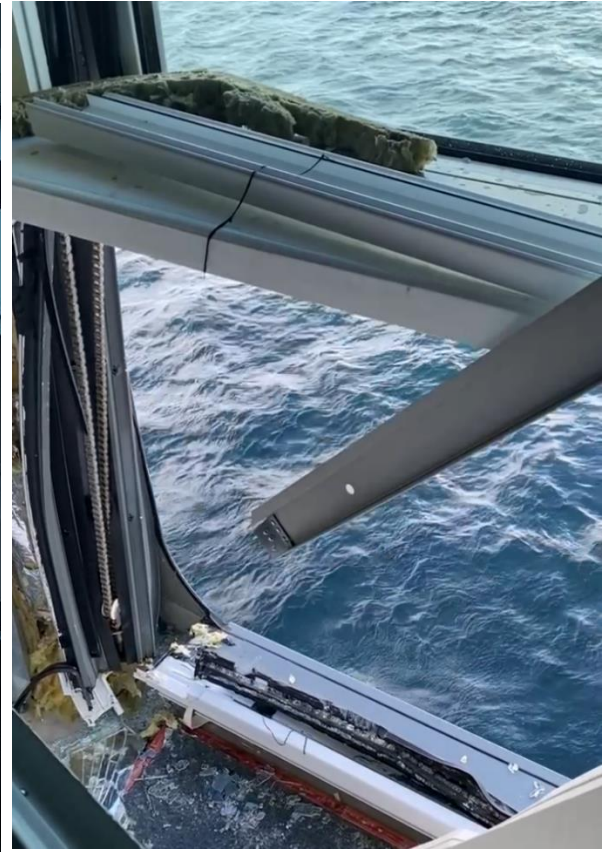
Figure 29: Window frame in stateroom 2018.
Photo: NSIA

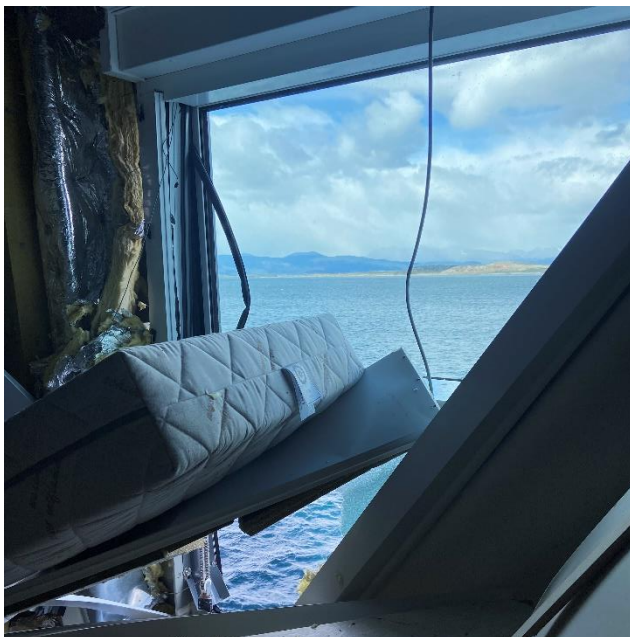
Figure 30: Damage to window and frame in stateroom 2020. Photo: NSIA

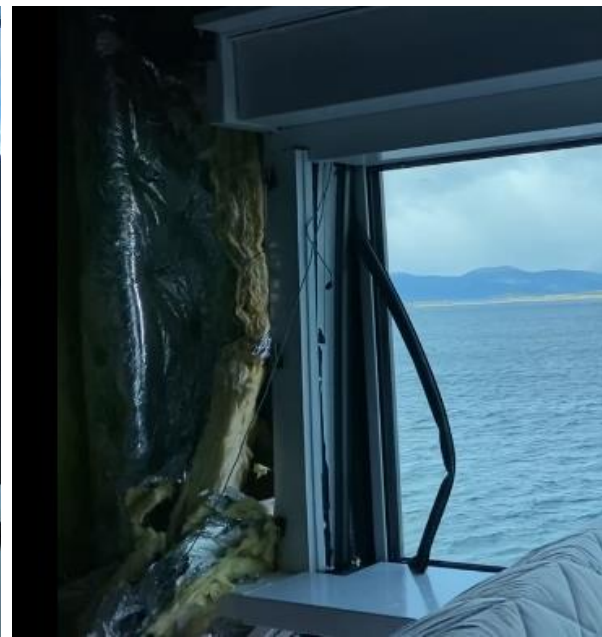
Figure 31: Damage to upper window frame in stateroom 2020. Photo: NSIA

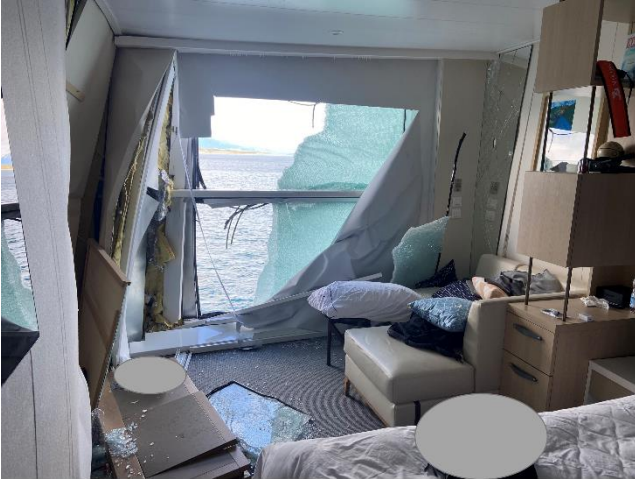
Figure 32: Damage in stateroom 2010. Photo: NSIA

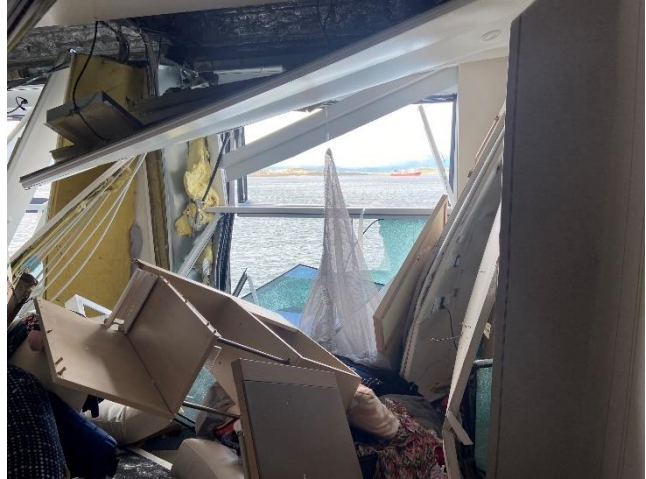
Figure 33: Damage in stateroom 2012. Photo: NSIA

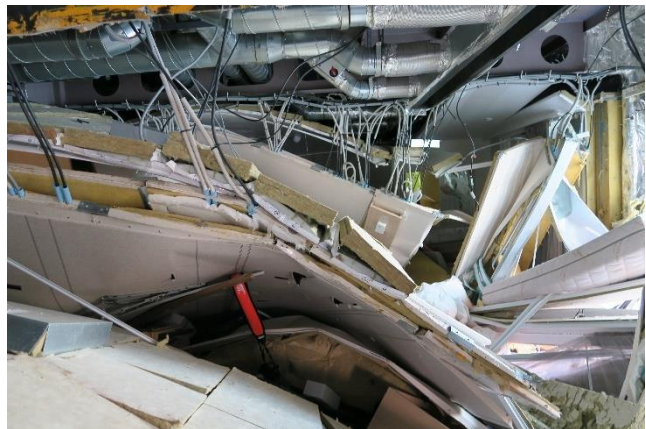
Figure 34 and Figure 35 show the part of the stateroom area that sustained the most damage. The ceiling had fallen down and walls between staterooms had been torn up and pushed backwards.

Figure 35: Photo from the damaged stateroom area showing how the ceiling and walls have been dislodged and pushed together. Photo: NSIA

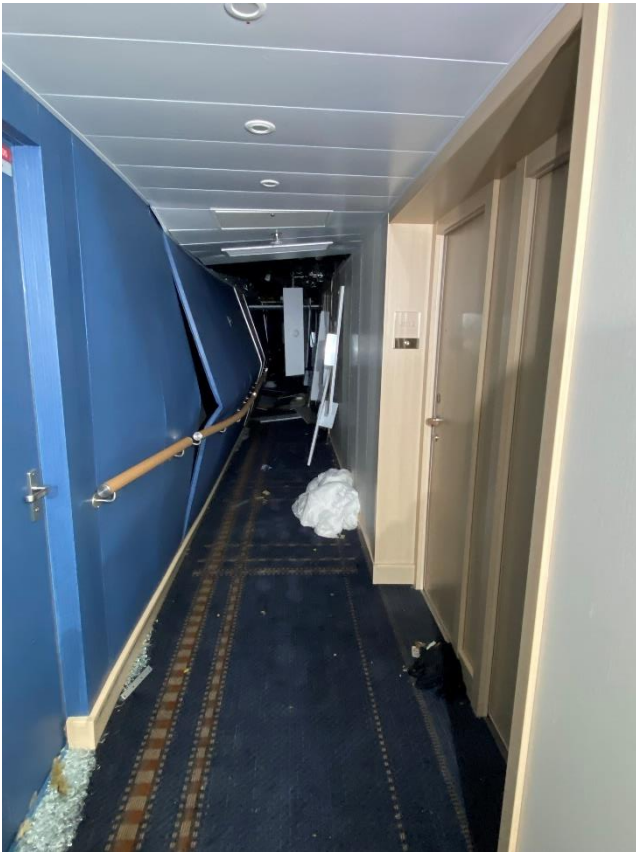
Figure 36: Damage to corridor viewed from staterooms 2010 and 2012 on deck 2, view towards the stern. Photo: NSIA

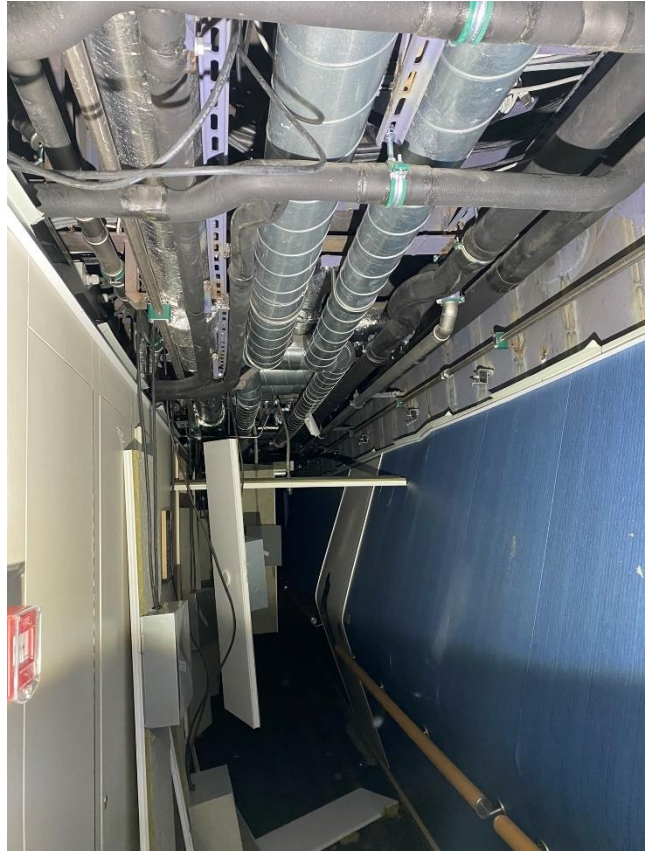
Figure 37: Damage to corridor and ceiling. Forward view. Photo: NSIA

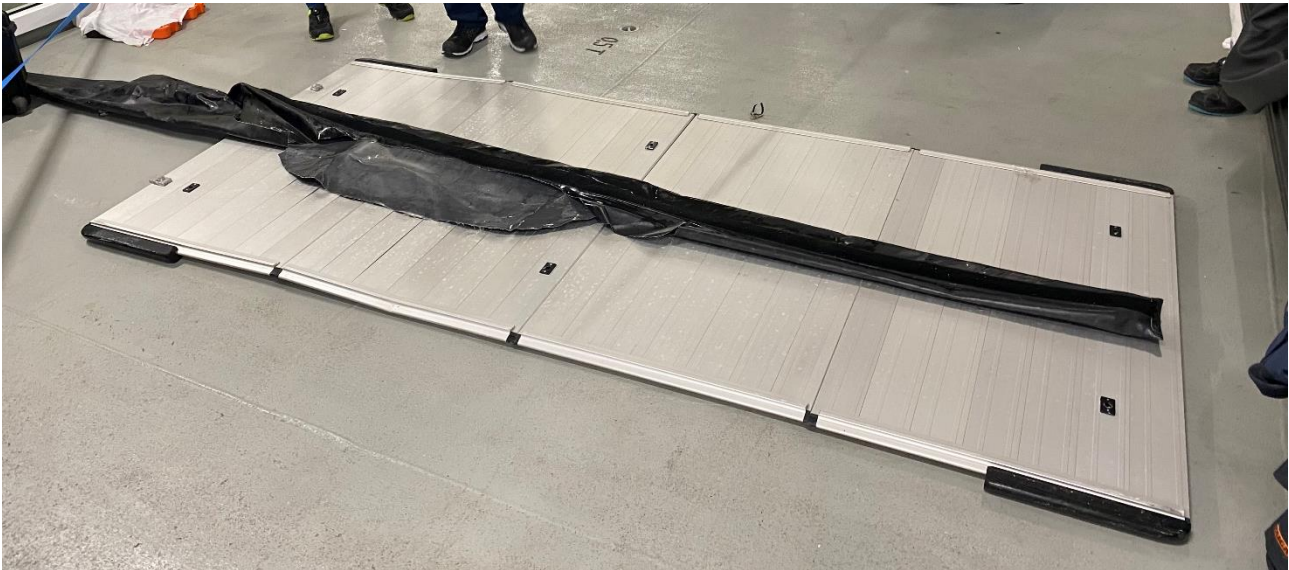
The centre keel was placed on top of the floorboards in its proper position, and when the torn part of the central keel was spread out, it followed the outline of the dents; see Figure 42.

Figure 42: The centre keel stretched out on the floorboards in the position it was in during the incident. Photo: NSIA

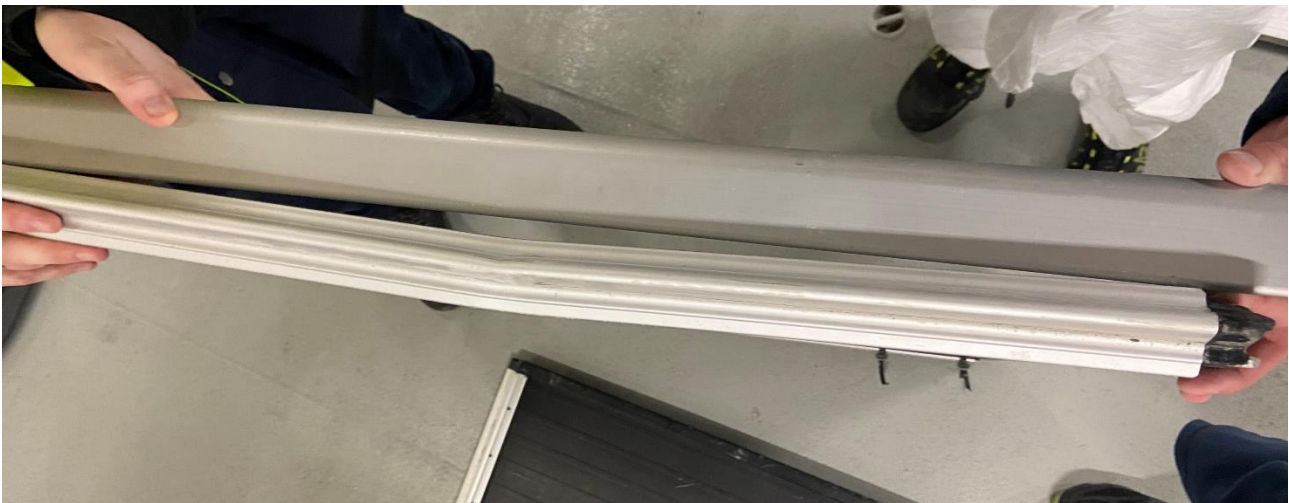
The floorboards in the damaged area were bent upwards by the explosion-like incident; see Figure 43 for a cross-section of a damaged floorboard.

Figure 43: The floorboards in the damaged area were bent. Photo: NSIA

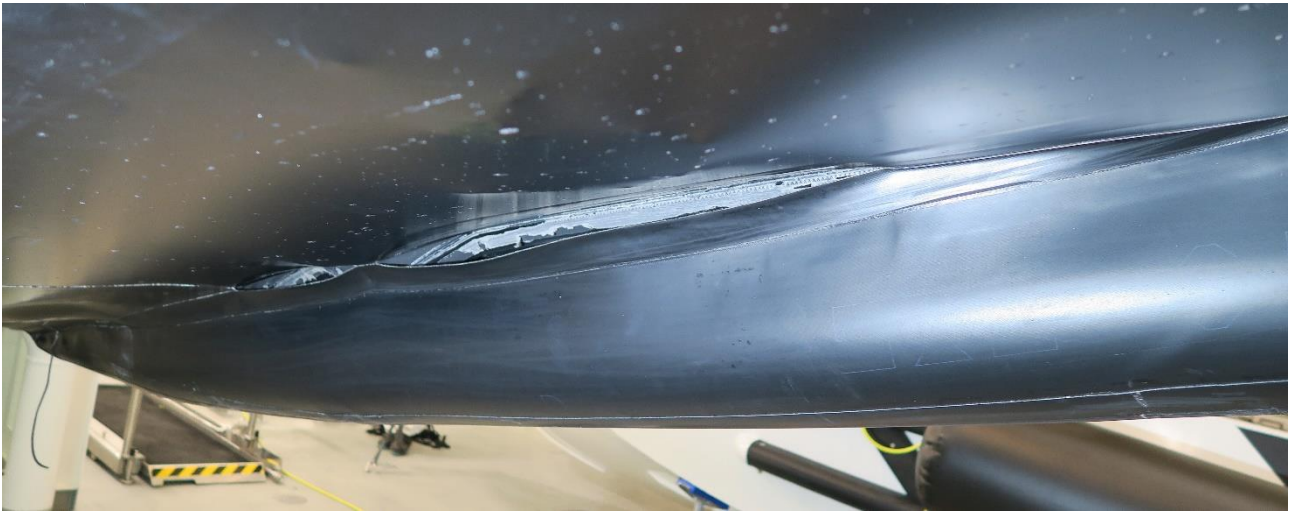
During the investigations, glue separation damage was found in both futura tubes located under the Zodiac on either side; see Figure 44.

Figure 44: Glue separation damage on the futura tube. Photo: NSIA

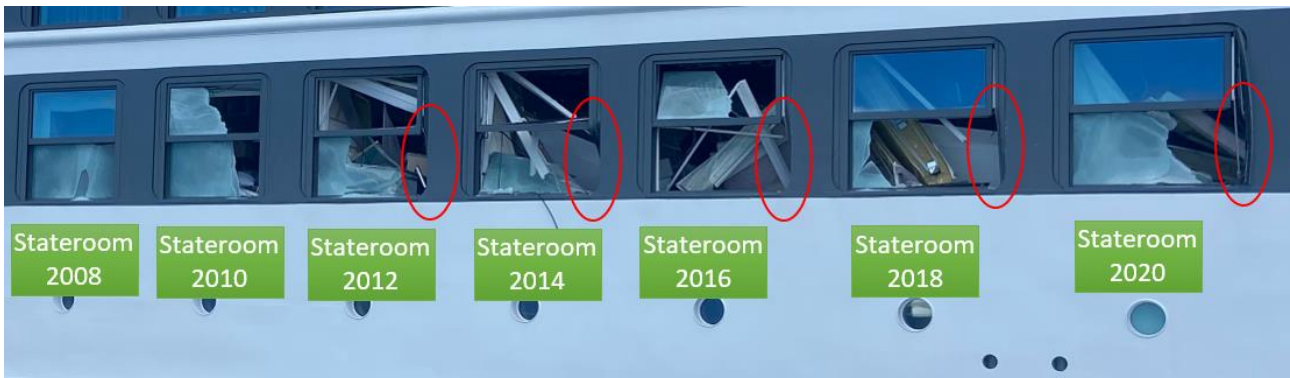
Figure 74: The overview photo shows the damaged staterooms on deck 2. The staterooms where the aft frame post was knocked in on five of the seven damaged windows are circled in red. Photo: NSIA/consultant

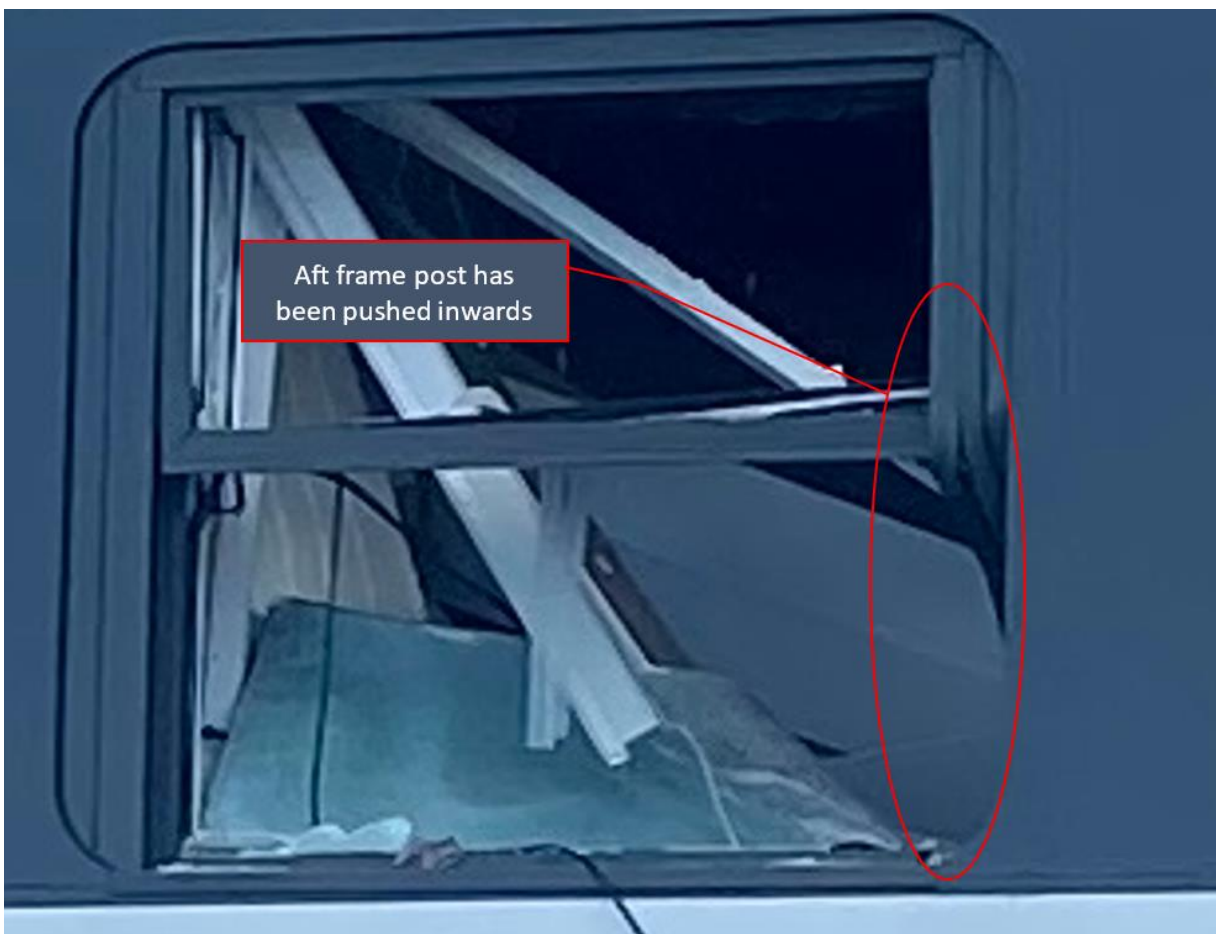
Figure 75: Frame post pushed into stateroom 2014. Photo: NSIA/consultant

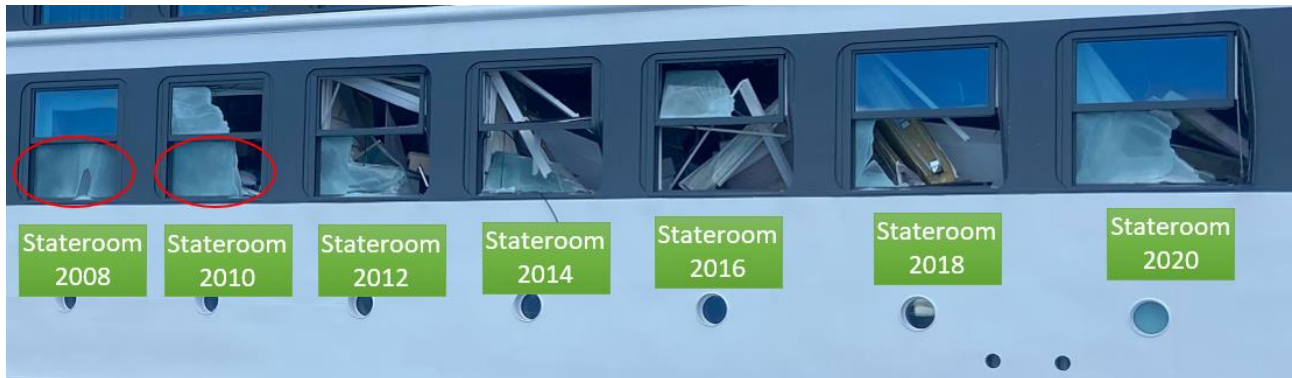
Figure 76: The windows where the window pane is broken but the frame is intact are circled in red.
Photo: NSIA/consultant

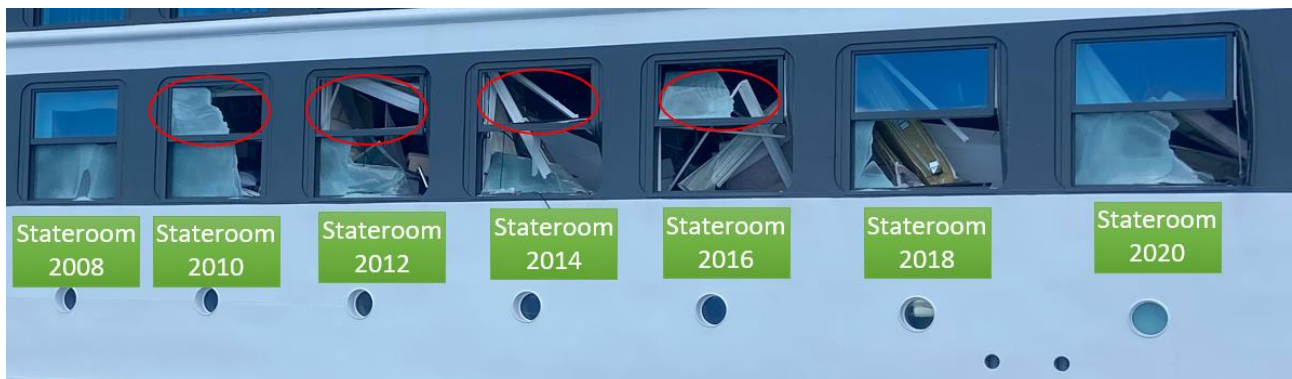
Figure 77: The windows where the window pane is broken, but the frame intact are circled in red.
Photo: NSIA/consultant

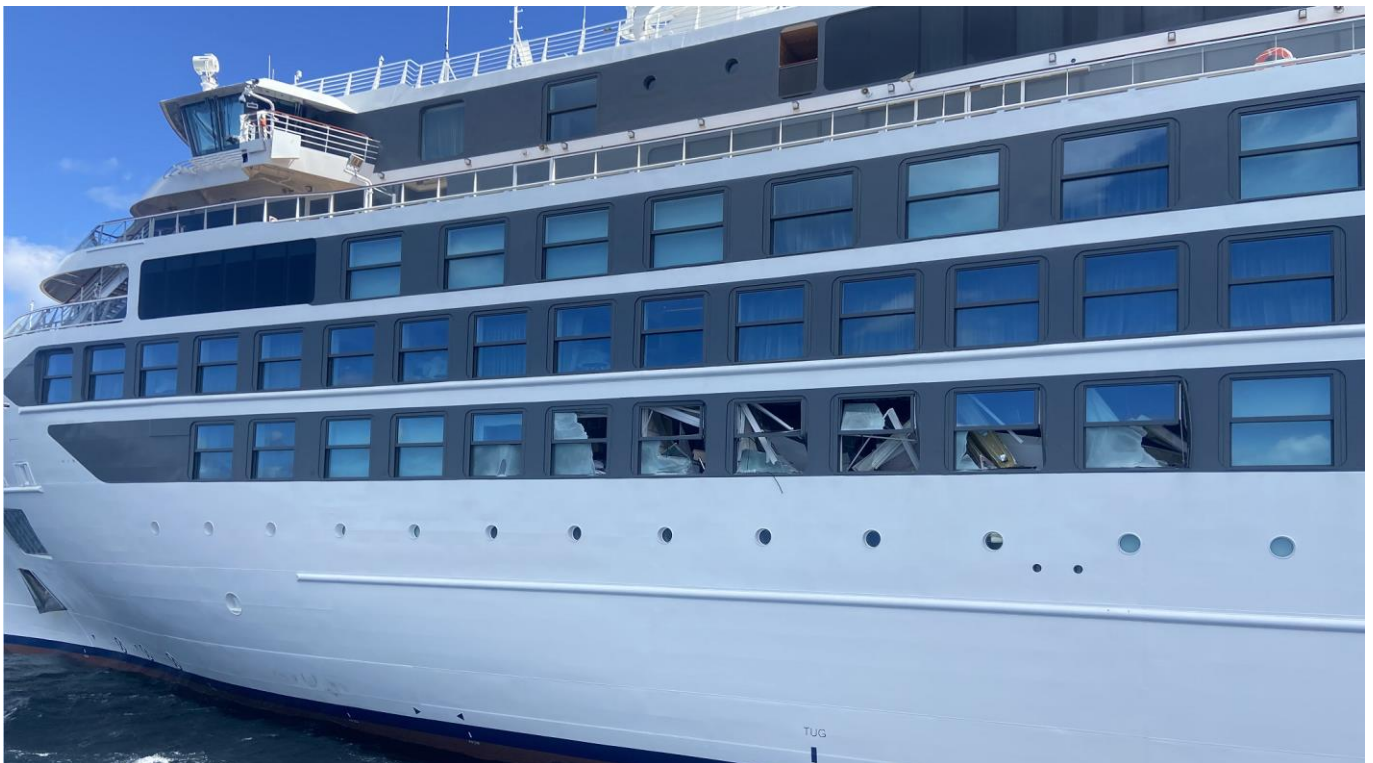
Figure 6-2 Photo of damage to the port side of 'Viking Polaris', deck 2, November 2022

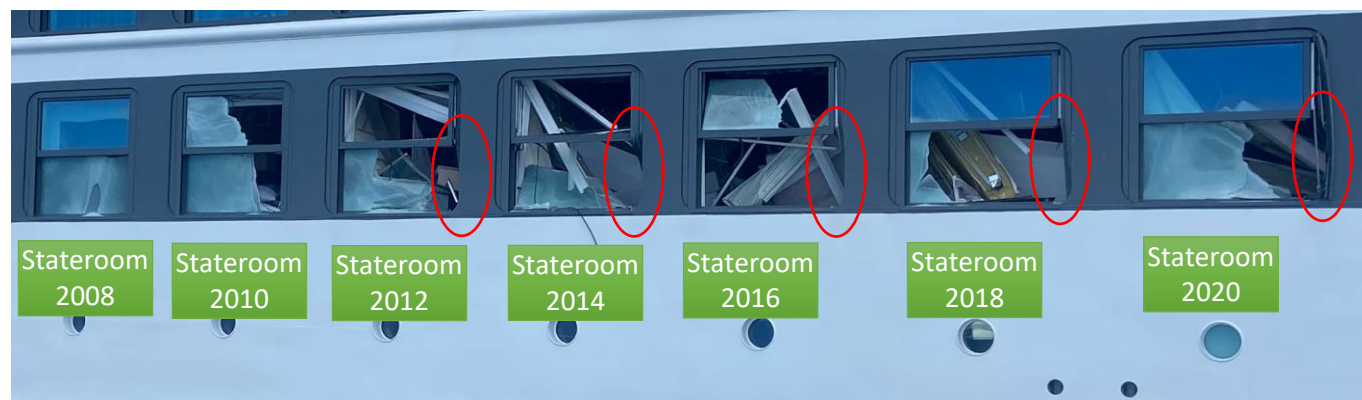
Figure 9-4 Overview photo showing the damaged staterooms on deck 2. We can see that the aft frame post is damaged on five of the seven damaged windows.
