Issued November 2023

REPORT MARINE 2023/06

***Marine casualty involving the cruise ship
'Viking Polaris' south-east of Cape Horn,
29 November 2022***

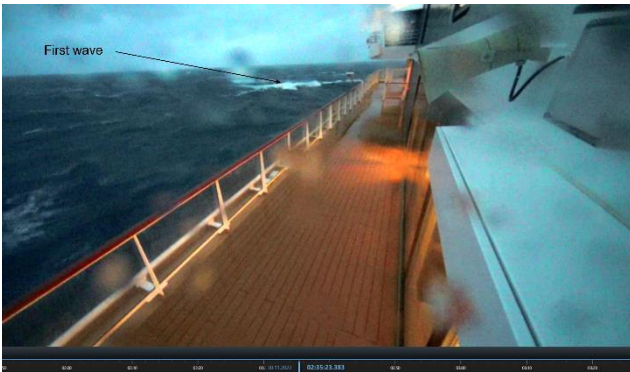
Figure 6: The first wave at 22:35:23. Source: CCTV

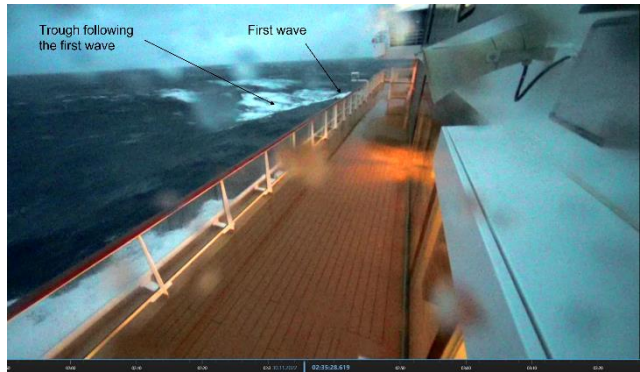
Figure 7: The first wave hitting the side of the ship. White foam is visible in the trough that follows at 22:35:28. Source: CCTV

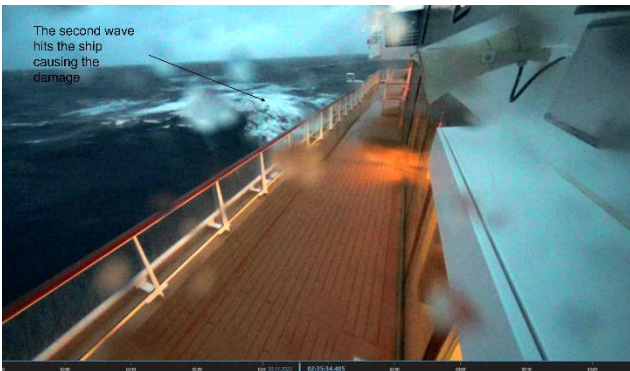
Figure 8: The second wave near the side of the ship at 22:35:34. Source: CCTV

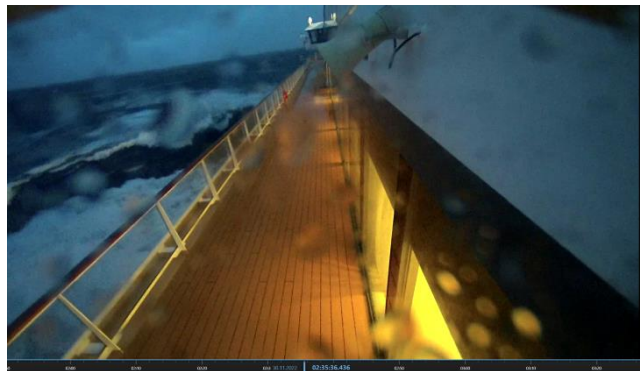
Figure 9: The second wave approaching the side of the ship at 22:35:36. Source: CCTV

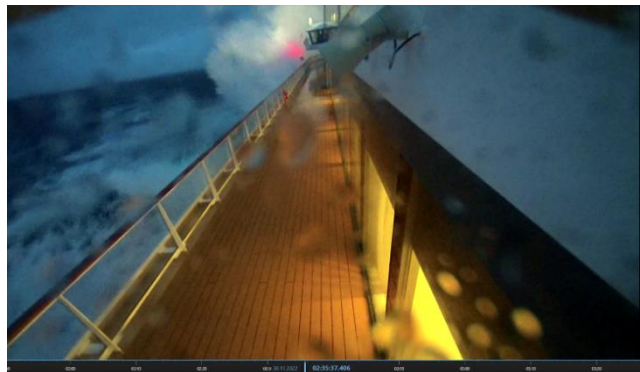
Figure 11: The wave hitting the side of the ship at 22:35:37. View from a camera further aft on deck 5. Source: CCTV

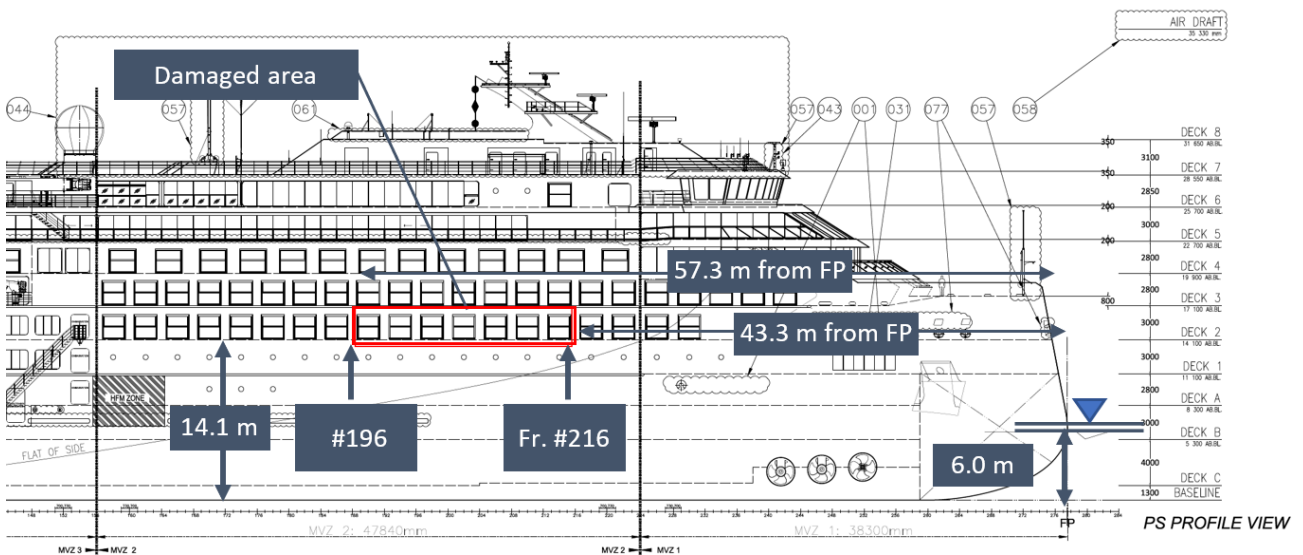
Seven stateroom windows on the port side of deck 2 shattered when the wave struck the ship. The first broken window was the fifth window on the port side of deck 2; see Figure 16 and Figure 17. No damage was observed to the hull plate directly below the windows. NSIA has later been information about some water entering two staterooms on deck 3. These windows were replaced, along with a total of 9 windows on deck 2 in connection with the repair work.

Figure 17: Illustration of the damaged area. The drawing is from starboard side, however the vessel has corresponding arrangement on port side where the damages occurred. Technical drawing: Shipyard, text boxes: consultant

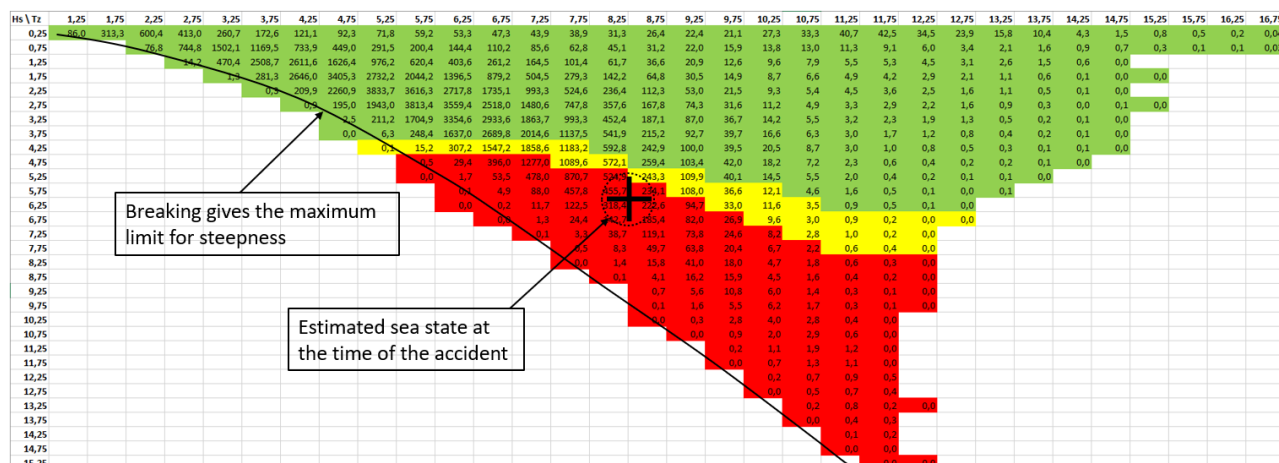
Figure 55: The scatter diagram for the Drake Passage. The line defines the maximum limit for steepness and the cross shows the forecasted sea state at the time of the accident. Source: Classification Society

The line in the scatter diagram defines the maximum limit for the steepness of the sea state. The waves will have an increasing steepness and probability of breaking when the sea state has a characteristic that approaches this limit. The colors in the diagram describe temporary operational weather restrictions that were introduced for Viking Polaris after the accident, and this is described in more detail in chapter 1.16.1.1.

The sea state at the time of the accident was forecasted to be H_s 6 m and T_p 11 s (roughly equivalent to T_z 8.5 s), marked with a cross in Figure 55.

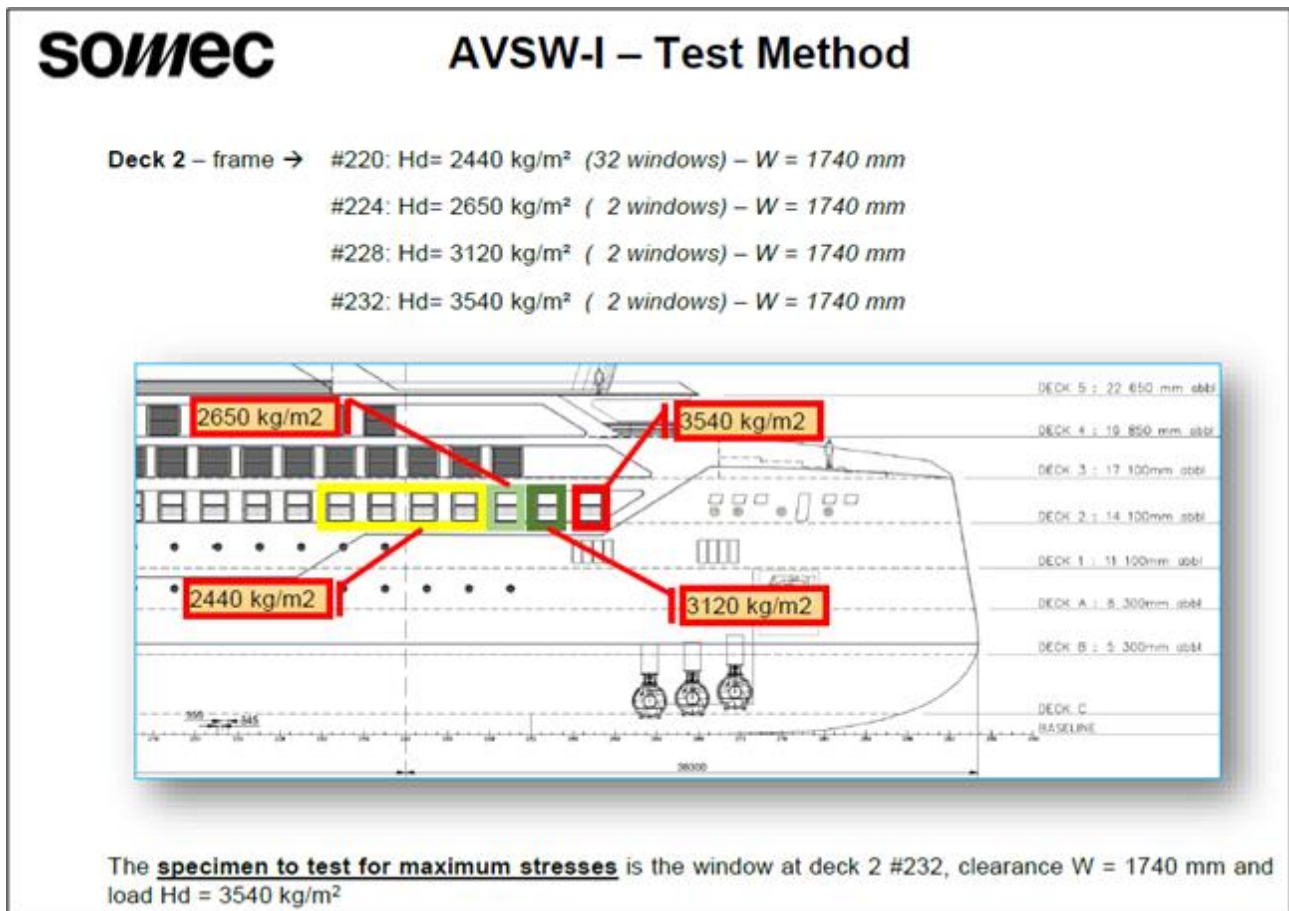
The design pressure for the sash windows varied depending on where on the ship the windows were located. The design pressure was calculated to 2.5 kPa for deck 6, 12.5 kPa for deck 4 and 18.1 kPa for deck 3. For deck 2, the design pressure varied depending on position. The aft part of deck 2 had a design pressure of 24.4 kPa. This pressure applied to all windows except the foremost three on each side, which had design pressures of 26.5 kPa, 31.2 kPa and 35 kPa, respectively; see Figure 58. All the broken windows were located on deck 2 and had a design pressure of 24.4 kPa.

Figure 58: Design loads on deck 2. The highest design pressures apply to the windows closest to the bow. The drawing is from starboard side, however the vessel has corresponding arrangement and design pressure at port side where the damages occurred. Source: Window supplier

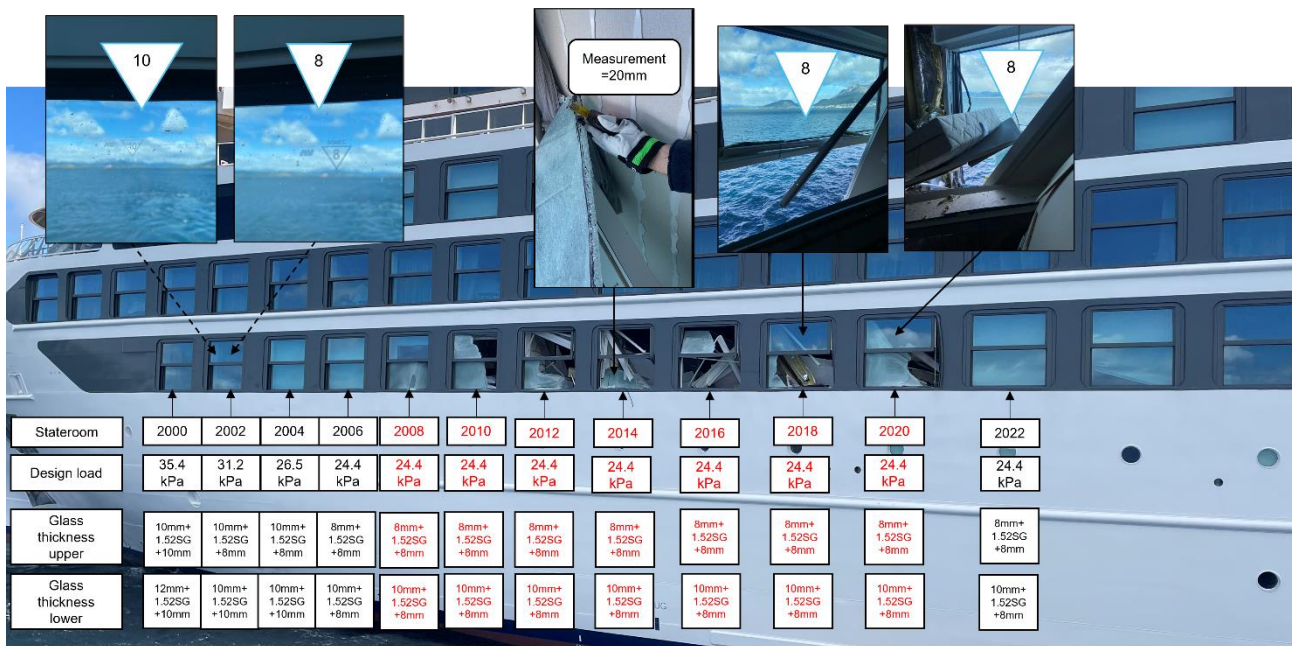
The windows were made from laminated glass consisting of two thick layers with a thinner layer of rigid plastic foil called Sentryglas (SG) with thickness 1.5 mm in between. The thicknesses used were indicated on the windows with a triangle representing the thickness of the glass; see Figure 60. Figure 60 also shows the windows' design pressures and other design parameters.

Figure 60: Design loads and glass thickness for the upper and lower windows on deck 2. Red text indicates which windows were broken. Photo/illustration: NSIA

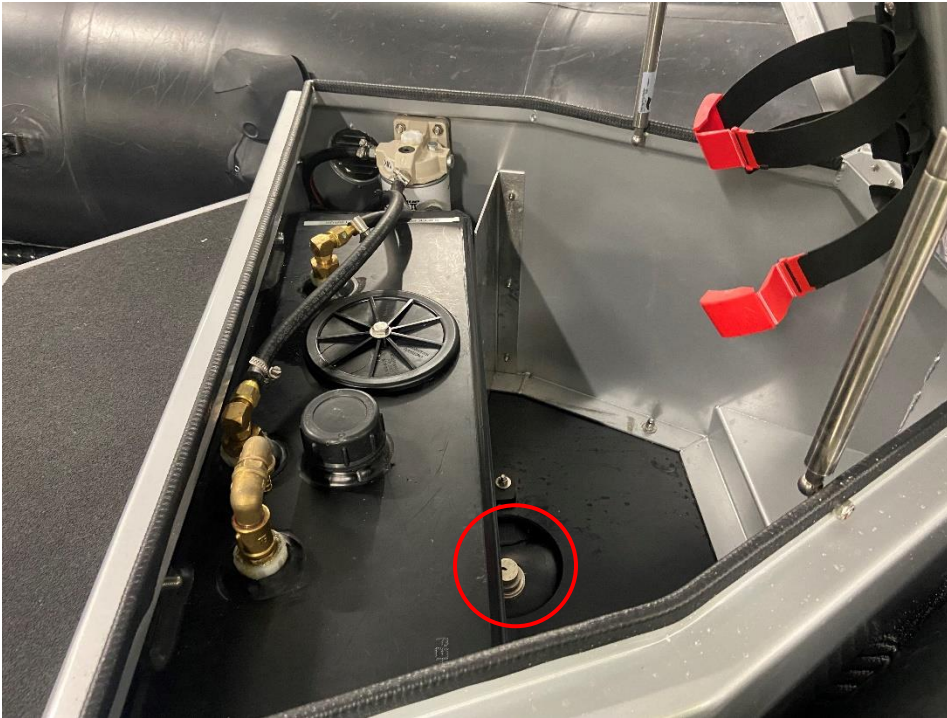
The manometer delivered with the boats was designed to be fitted to an inflation valve and the pressure read from the side. To read the pressure in the inflatable keel, one would either have to photograph the manometer while fitted to the inflation valve inside the box, or empty the aluminium box out and visually read the pressure upside down leaning forward with one's head in the box. Figure 67 shows the aluminium box at the bow and the valve for the inflatable keel.

Figure 67: The aluminium box at the bow of one of the Zodiacs. The valve for the inflatable keel is indicated by a red circle. Photo: NSIA

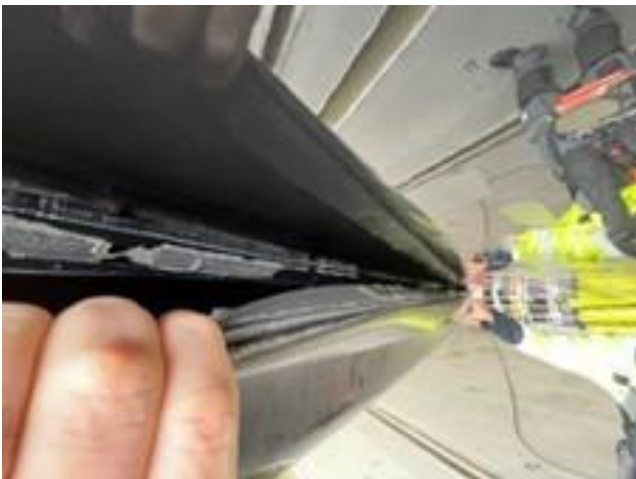
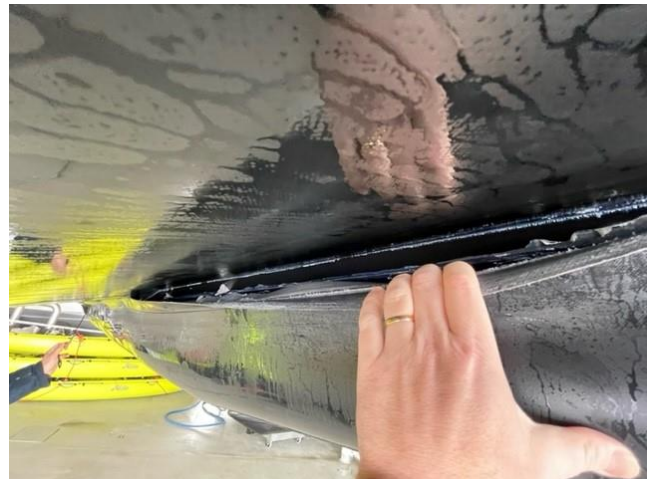
- Voyage 2: glue separation detected on Zodiacs 4 and 12. They were taken out of operation.
- Voyage 3: partial glue separation detected at the futura tubes of Zodiacs 20 and 24 and on one side of Zodiac 28.
- Voyage 4: glue separation detected on Zodiac 22 in connection with the accident.

Figure 68: Glue separation at futura tube of Zodiac 12. Photo: Ship management company

Figure 69: Glue separation at futura tube of Zodiac 12. Photo: Ship management company

The air pressure of the centre keel of all these Zodiacs was measured to PSI ≥ 9 after the accident; see section 1.6.4.3.

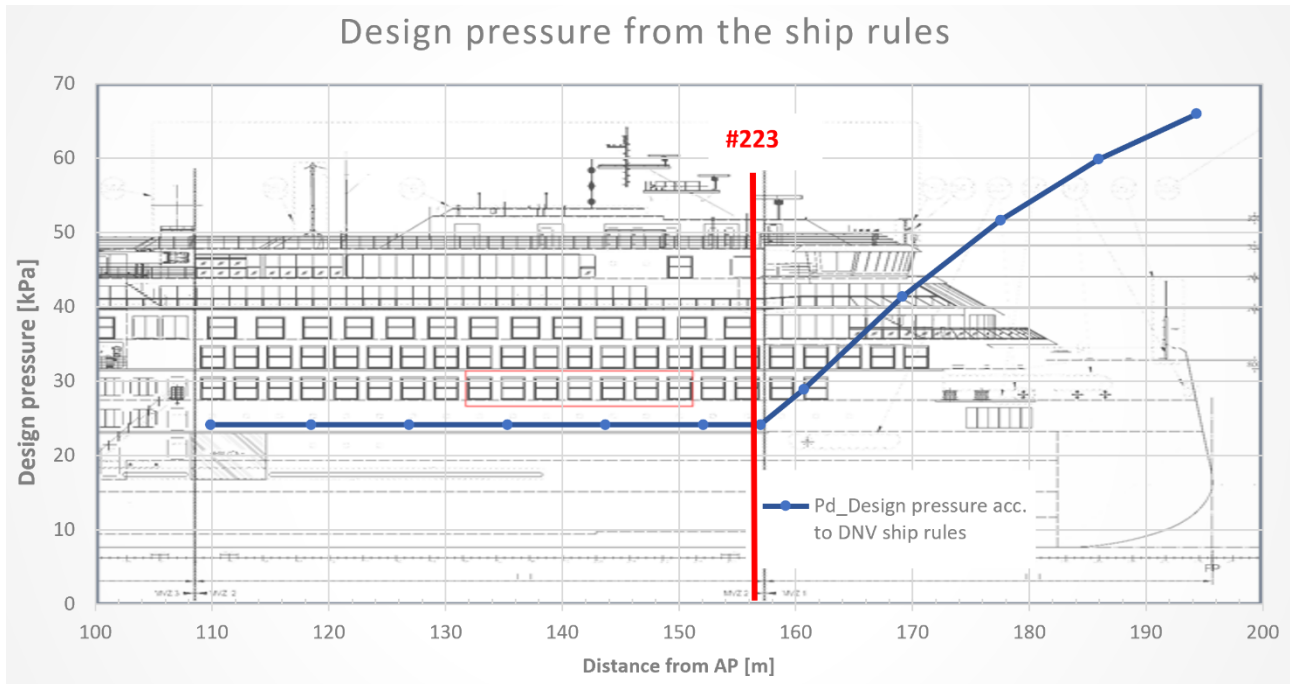
Forward of frame #223, the design pressure is calculated based on design waves for the oncoming sea, which results in increased design pressure requirements; see Figure 72. In order to verify the design pressure calculation, the consultant ran a separate analysis in the ship design tool Nauticus Hull (in which the formulas from the regulations are implemented) to determine the value of external pressure on the hull between decks 2 and 3. The results show good correlation between the pressures. Nauticus Hull was also used by the shipyard to calculate the design pressure on 'Viking Polaris' during the design phase.

Figure 72: Regulation pressure for the side of the ship. Drawing is of starboard side, however the vessel has corresponding arrangement and design pressures on the port side were the damages occurred. Illustration: Consultant

The study therefore concluded that the design pressure used for the construction and testing of the windows and fixings were calculated correctly in accordance with the ship rules.

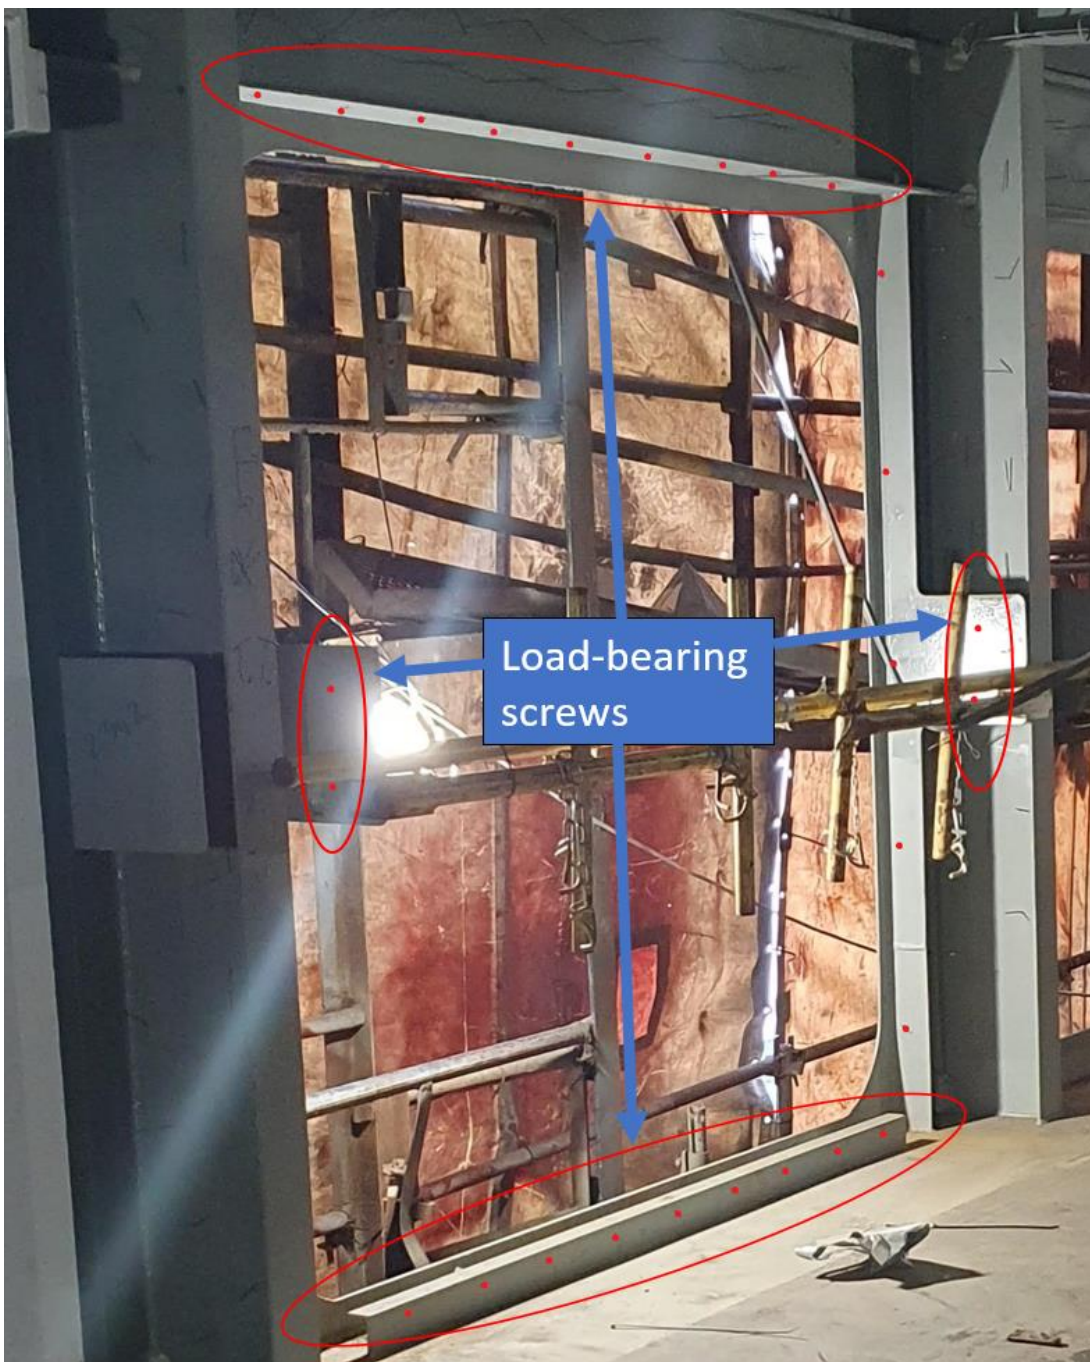
The spacing between the screws fastening the window frame to the ship structure must not exceed 150 mm. The windows in question were attached with different types of screws that were also spaced at different intervals. The spacing between the load-bearing screws varied between 222 mm and 230 mm. The capacity of the window fixings, including frame, bolts and stiffeners, are evaluated by class society to be in accordance with the applicable rules through the equivalence principle stated in Pt.1 Ch.1 Sec.1 [2.5.9], by performing a strength test of the complete installation. The load-bearing screws are highlighted in Figure 73. The remaining screws hold a thin aluminium profile with low load-bearing capacity and are therefore not considered load-bearing.

Figure 73: Screws fastening. The red dots show the location of the screws. The load-bearing screws are highlighted. Photo: Window supplier / modified by the consultant

No damaged or broken load-bearing screws were found for the windows studied in this report. It can therefore be concluded that the load-bearing screws were of sufficient strength for the windows in question.

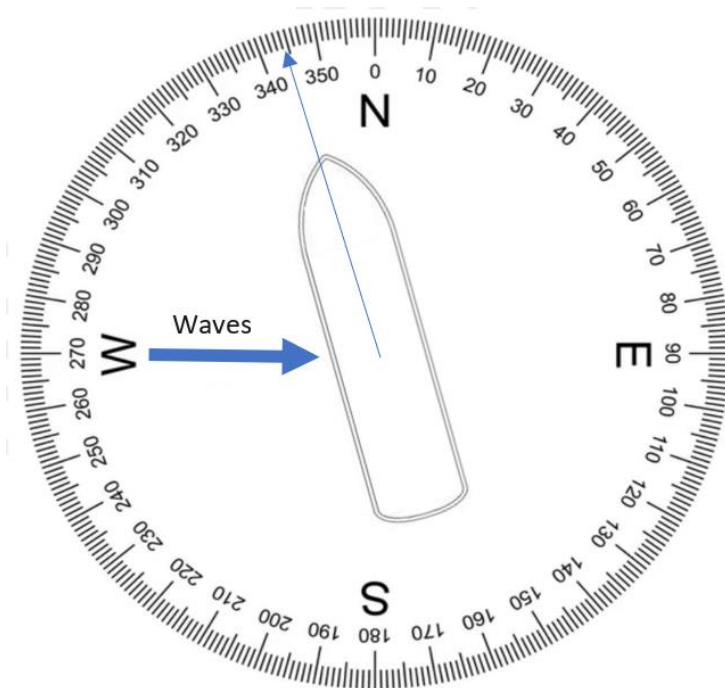
The weather forecast at the time of the accident predicted waves from 270 degrees (from the west). According to the Voyage Data Recorder (VDR), the ship's heading was 344 degrees immediately before the accident. This gives a wave direction relative to the ship's length of 74 degrees to port relative to the ship's length; see Figure 79. This wave direction is supported by observations from the CCTV cameras. The relative wave direction is therefore estimated to about 60–80 degrees to port.

Figure 79: Relative wave direction. Illustration: Consultant

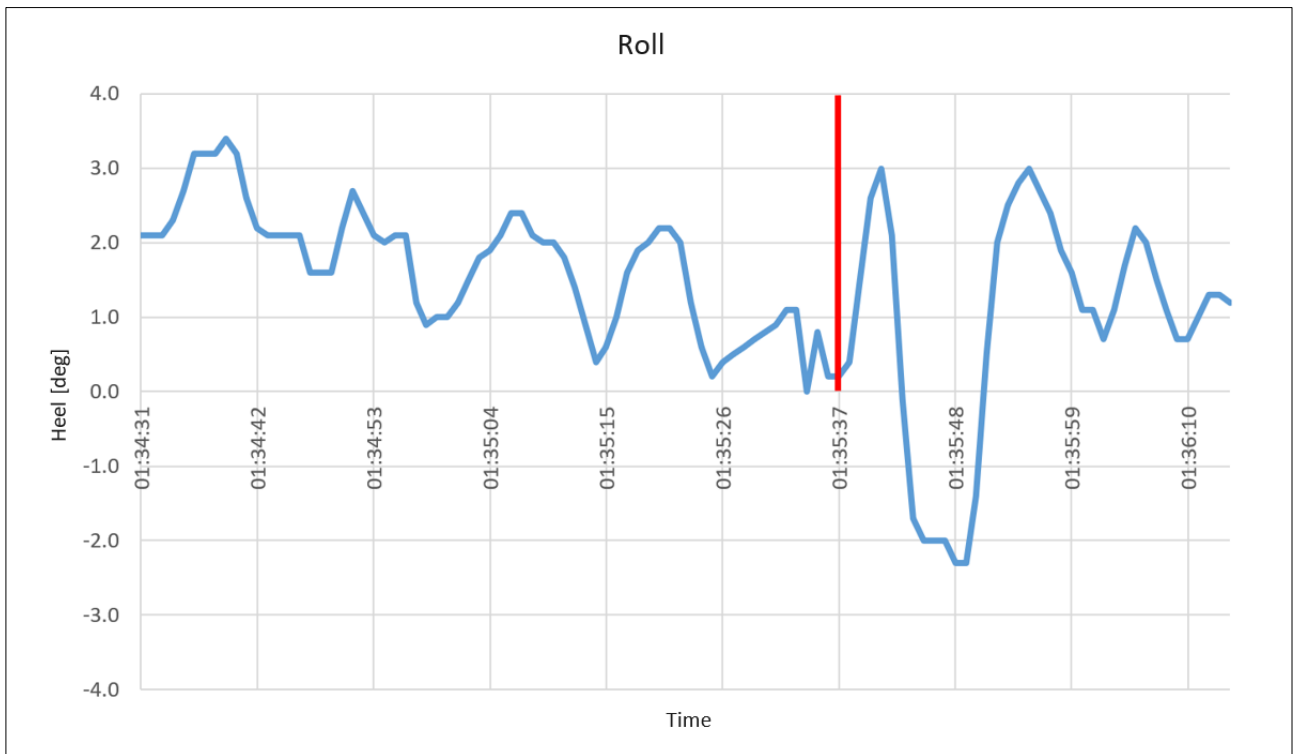
Figure 80: Roll motion after the accident. The wave strikes at 01:35:37. The positive angle is a starboard list. Source: The ship's machinery log.

The accident wave struck the ship on the port side at 01:35:37 (UTC). The wave can be characterised as an impulse load that sets the ship in motion and leads to a maximum angle of heel of 3.0 degrees to starboard 4 seconds after the impact, i.e. at 01:35:41. Then, the ship rolled to port with a maximum impact of -2.3 degrees after 11 seconds (at 01:35:48), before it rolled back to starboard with an angle of heel of 3.0 degrees after 18 seconds (at 01:35:55).

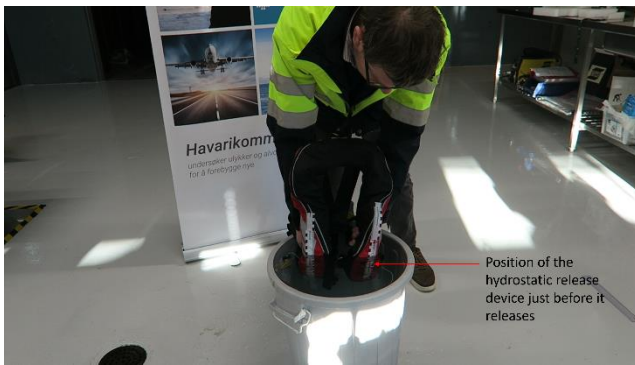
The lifejacket was then immersed in a bucket containing about 40 litres of water at a temperature of about 10 °C. The lifejacket was lowered into the bucket at a speed of approx. 0.5–1.0 cm per second. After the hydrostatic release unit had been submerged, the one on the right-hand side was released approximately 3–4 cm into the water; see Figure 81 and Figure 82.

Figure 81: Position of hydrostatic release unit just before the right gas cylinder is released. Photo: NSIA

Figure 82: The right-hand side of the lifejacket inflates after being submerged to a depth of about 3–4 cm. Photo: NSIA

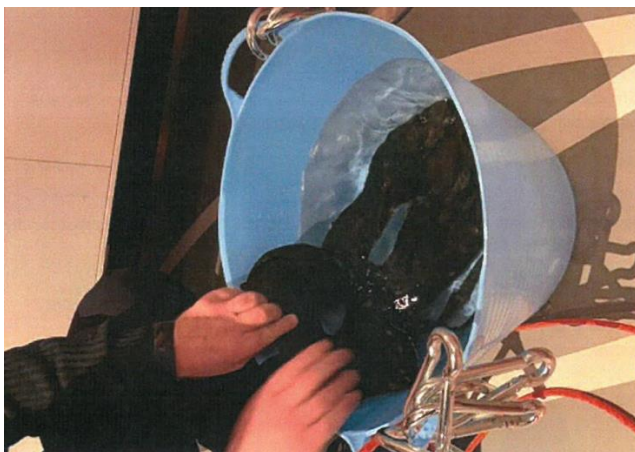
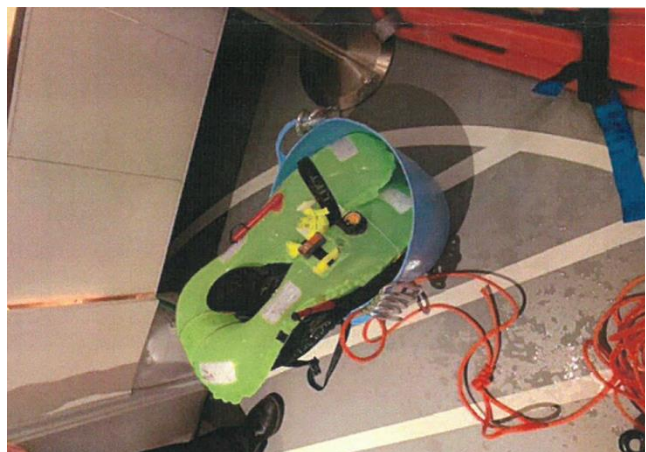
A bucket was filled with water and the lifejacket lowered into the bucket. The hydrostatic release unit was reportedly released after a few seconds.

Figure 83: Lifejacket being lowered into a bucket. Photo: Crew

Figure 84: Lifejacket inflating. Photo: Crew

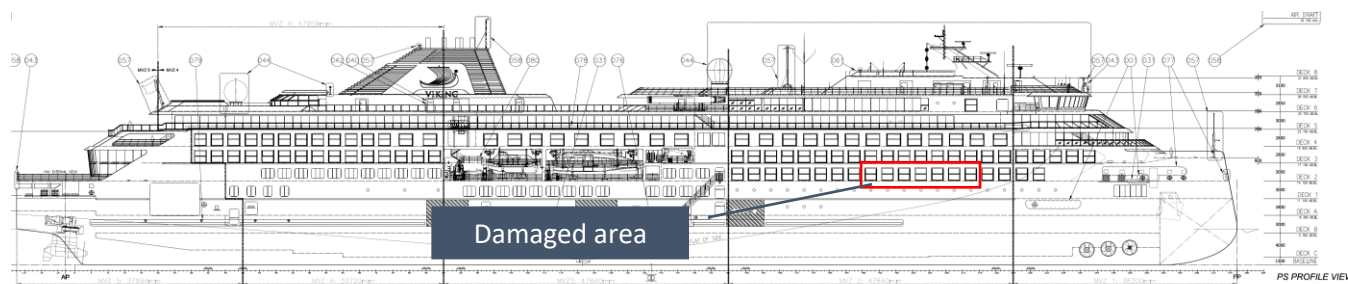
Figure 5-1: General arrangement and profile of starboard side where the damaged area is shown. Note that, although this figure shows the starboard side, the damage occurred on the port side, which has the same profile as the starboard side.

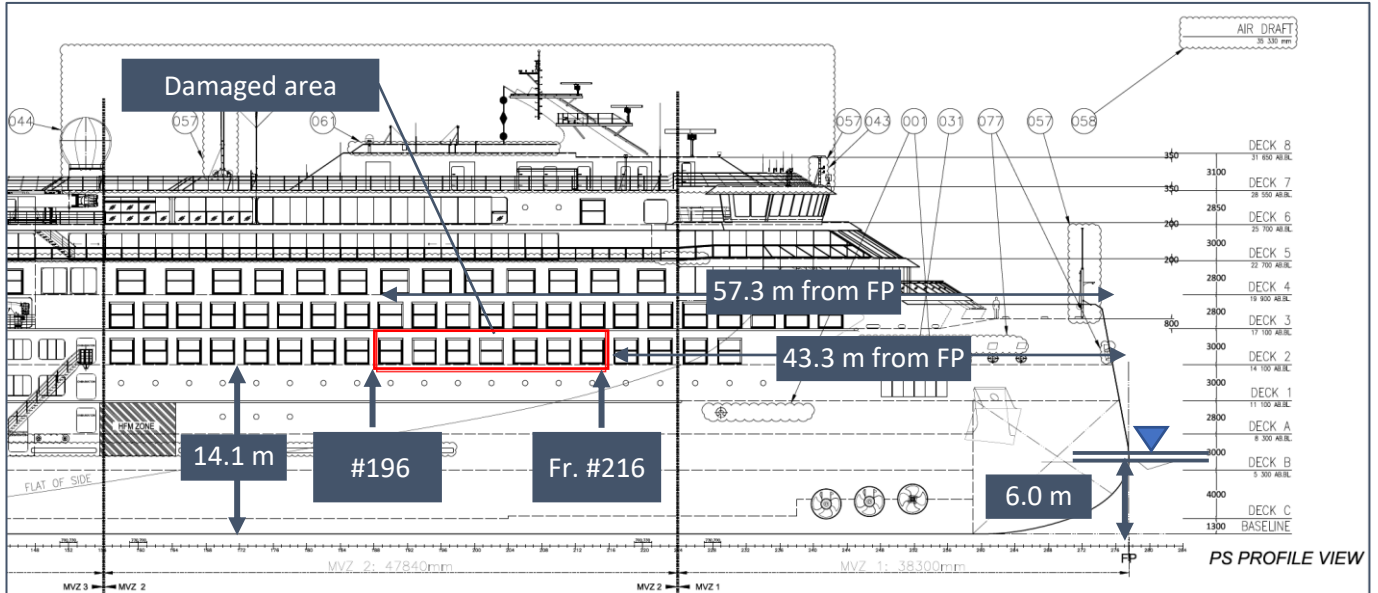
The damage consisted of windows that were partially shattered and pushed in, and subsequent damage to fixtures and fittings in the staterooms. The area that was damaged was on deck 2, 14.1 metres above the keel and

between 43 and 57 metres from the foreship (FP). The minimum still-water freeboard at the time of the accident is estimated to about 8 metres.

Figure 6-1 Illustration of damaged area – illustrated from starboard side on the drawing

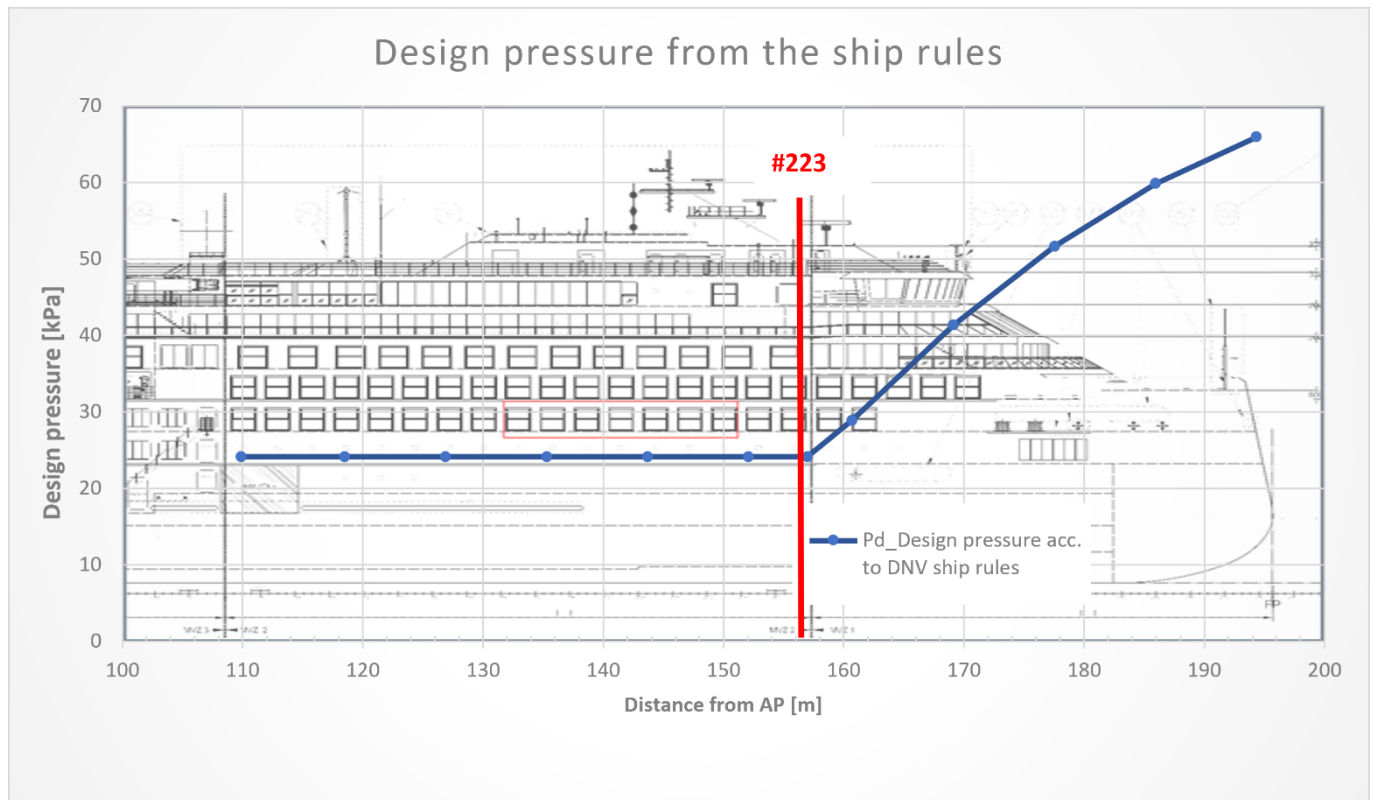
Forward of frame #223, the design pressure is calculated based on design waves for the oncoming sea, which results in increased design pressure requirements; see Figure 8-3. The results of the study are shown in Table 8-1 and show good correlation between the pressures. The study therefore concludes that the design pressure used for the design and testing of the windows and fixings were calculated correctly in accordance with the ship rules.

Figure 8-3 Rule pressure for the ship's side.

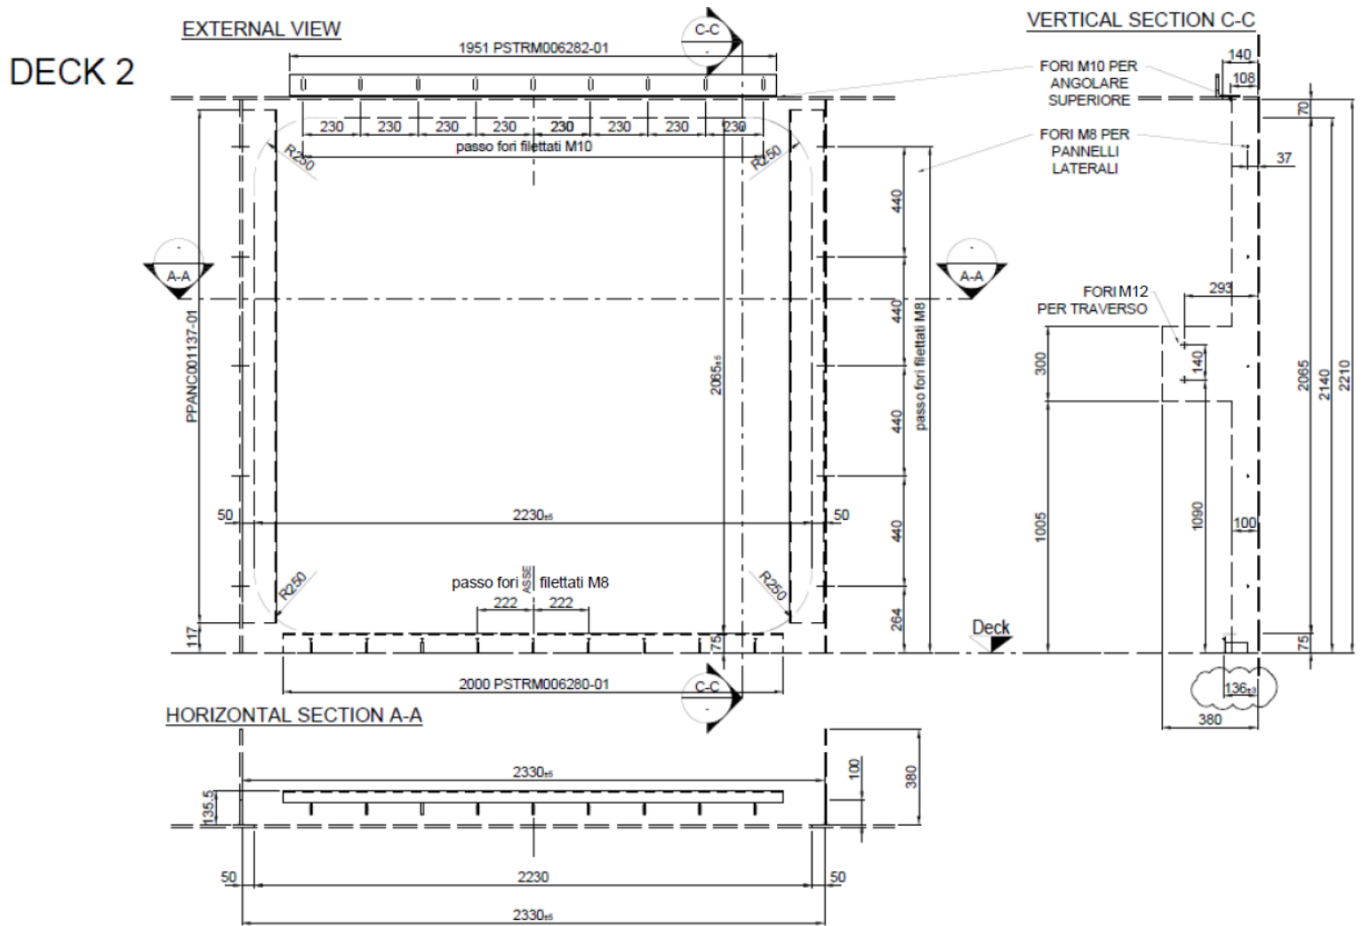
The spacing between the screws fastening the window frame to the ship structure must not exceed 150 mm. The windows in question were attached with different types of screws that were also spaced at different intervals. The spacing between the load-bearing screws varied between 222 mm and 230 mm. The capacity of the window fixings, including frame, bolts and stiffeners, are evaluated by class society to be in accordance with the applicable rules through the equivalence principle stated in Pt.1 Ch.1 Sec.1 [2.5.9], by performing a strength test of the complete installation. The fixing of the screws is shown in Figure 9-2 and Figure 9-3. The load-bearing screws are highlighted in Figure 9-3. The remaining screws hold a thin aluminium profile with low load-bearing capacity and are therefore not considered load-bearing.

No damaged or broken load-bearing screws were found for the windows studied in this report. It can therefore be concluded that the load-bearing screws were of sufficient strength. This has also been verified by a full-scale pressure test as explained in section 10.2.

Figure 9-2 Screw fixing, deck 2

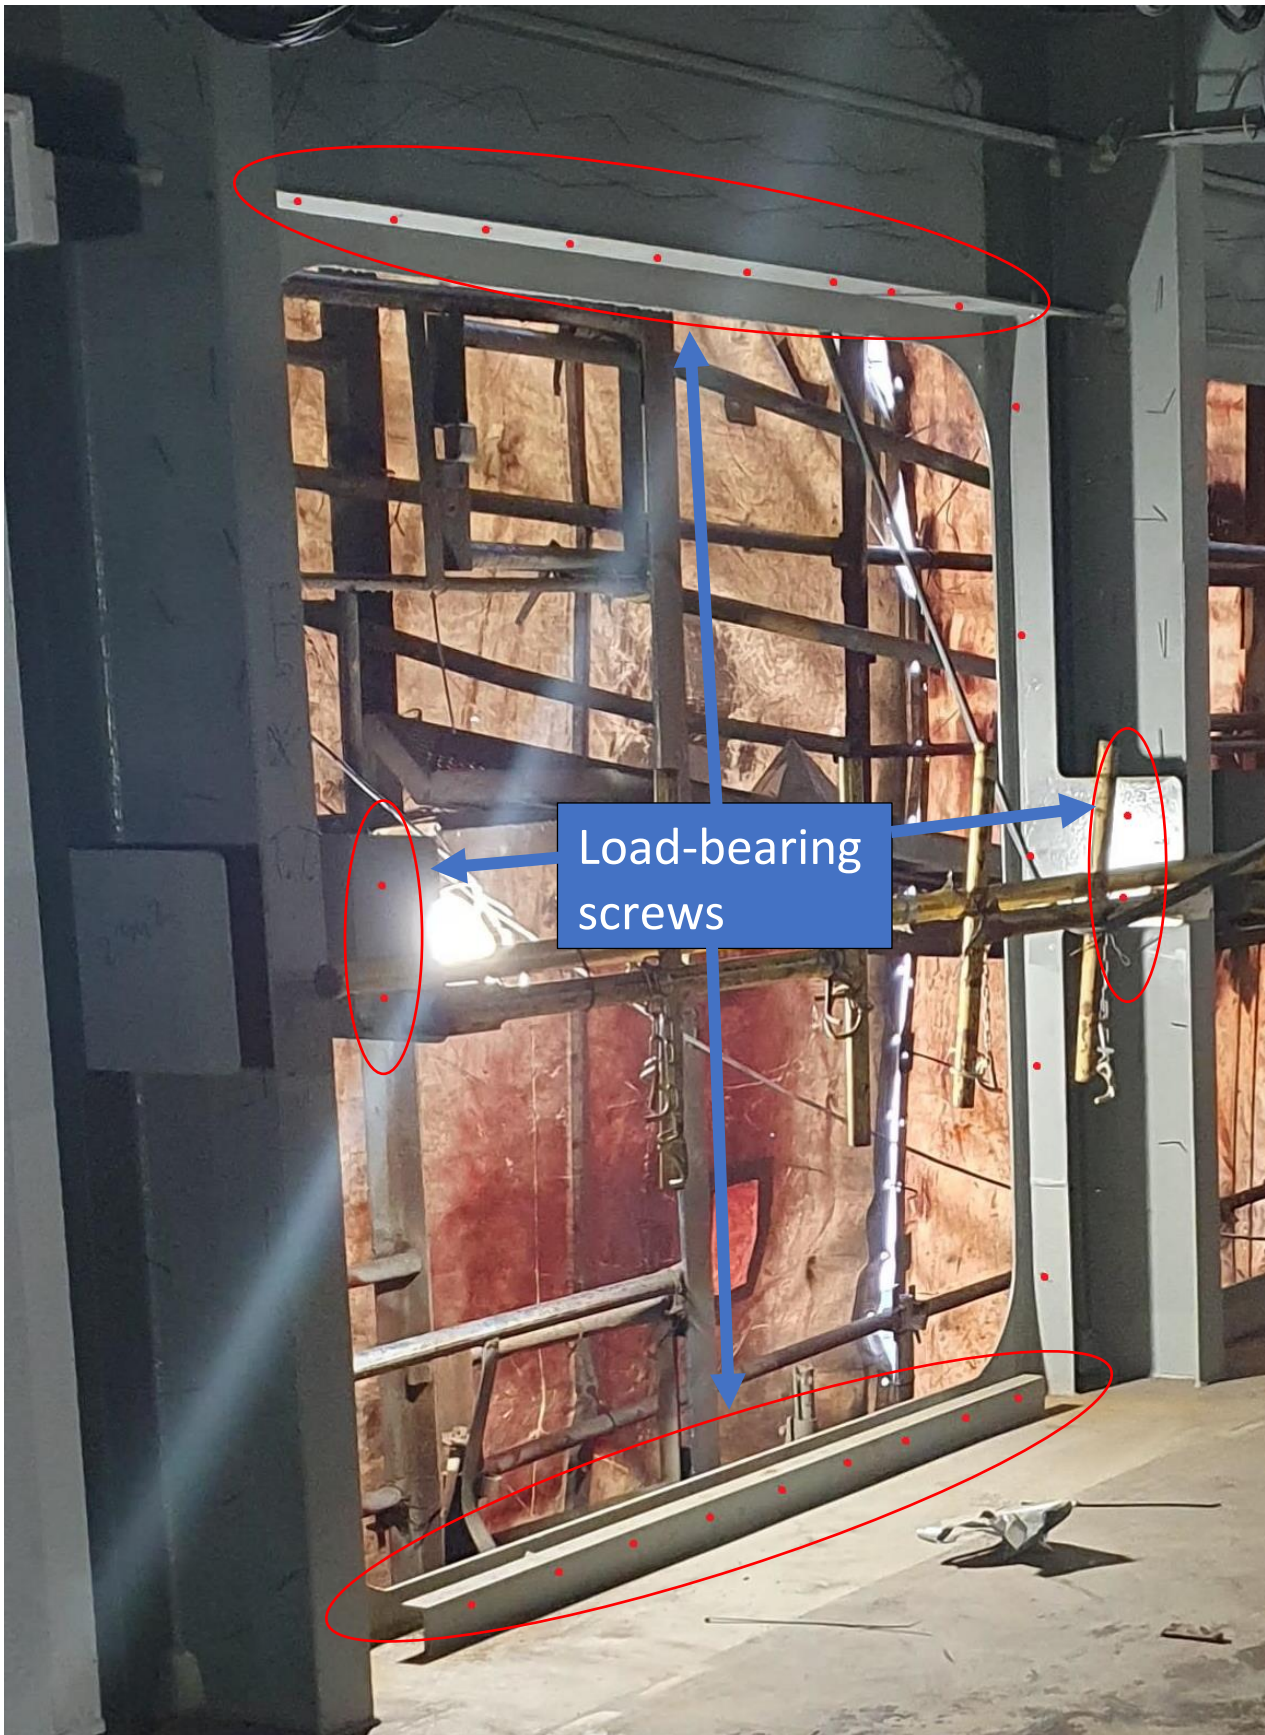
Figure 9-3 Screws fastening. The red dots show the location of the screws. The load-bearing screws are highlighted.

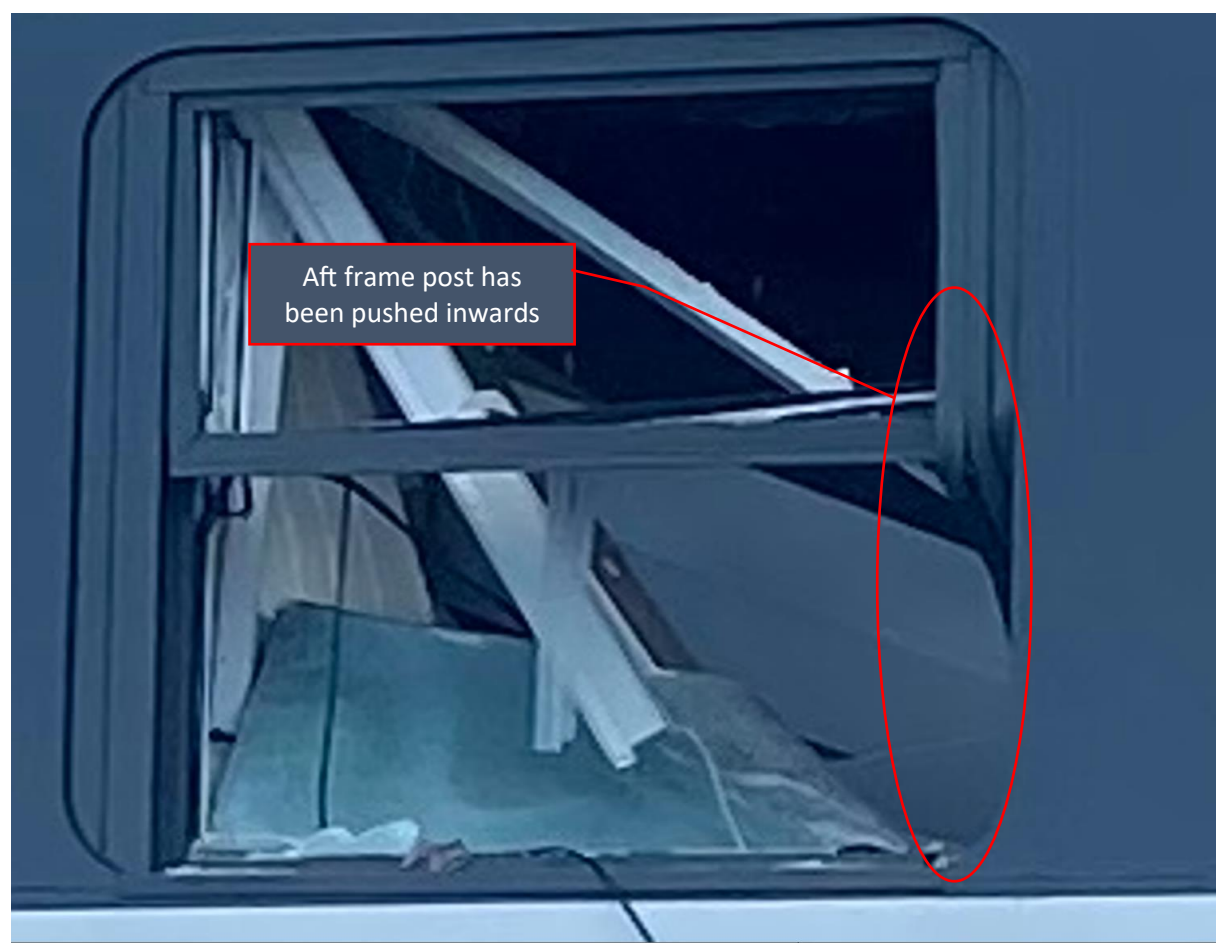
In five of seven staterooms (2012, 2014, 2016, 2018 and 2020), the aft frame post has been knocked in; see Figure 9-4 and Figure 9-5. For these windows, it can be concluded that the frame post was knocked in while pulling the shortest (aft) side of the window pane with it, thereby shattering the glass. That means that the frame yielded before the pane, and that the pane shattered as a result of high pressure and inadequate support from the frame post.

Figure 9-5 Window of stateroom 2014

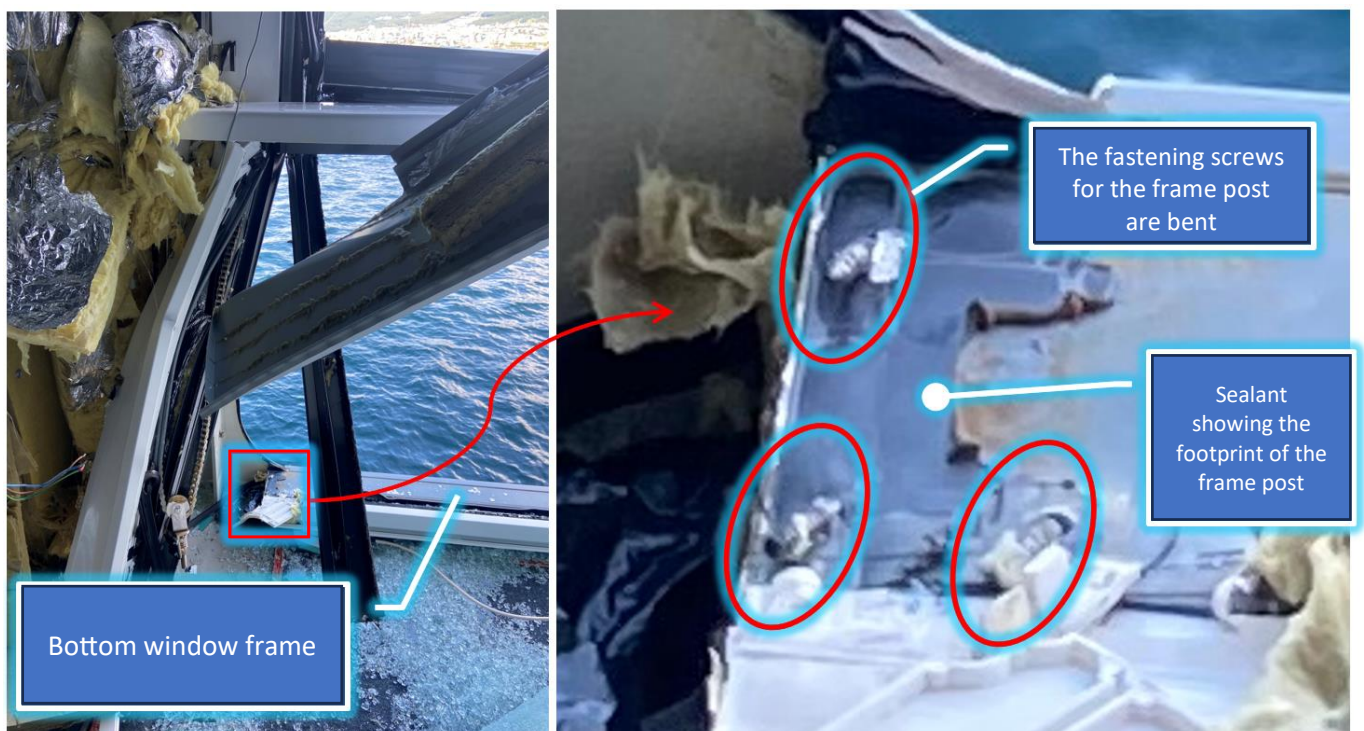
Figure 9-6 shows a close-up photo of the aft frame post. We see that three of six fastening screws are bent as a result of the frame post being pushed into the stateroom. The six fastening screws used to attach the frame post are shown in Figure 9-7.

The full-scale pressure test that was carried out (see section 10.2) showed that the frame was able to withstand a test pressure of 40 kPa. The windows and frames for these staterooms had a design pressure of 24.4 kPa. The fact that the frame withstood a higher pressure but yielded first suggests that the pressure has been higher than 40 kPa and thus far higher than what the window was designed for. If the frame post had been attached to the hull with load-bearing screw, it would have been able to withstand the pressure from the wave. As the pressure from the wave far exceeded the design pressure, however, the window would in any case have been shattered.

Figure 9-6 The weakest point of the window frame

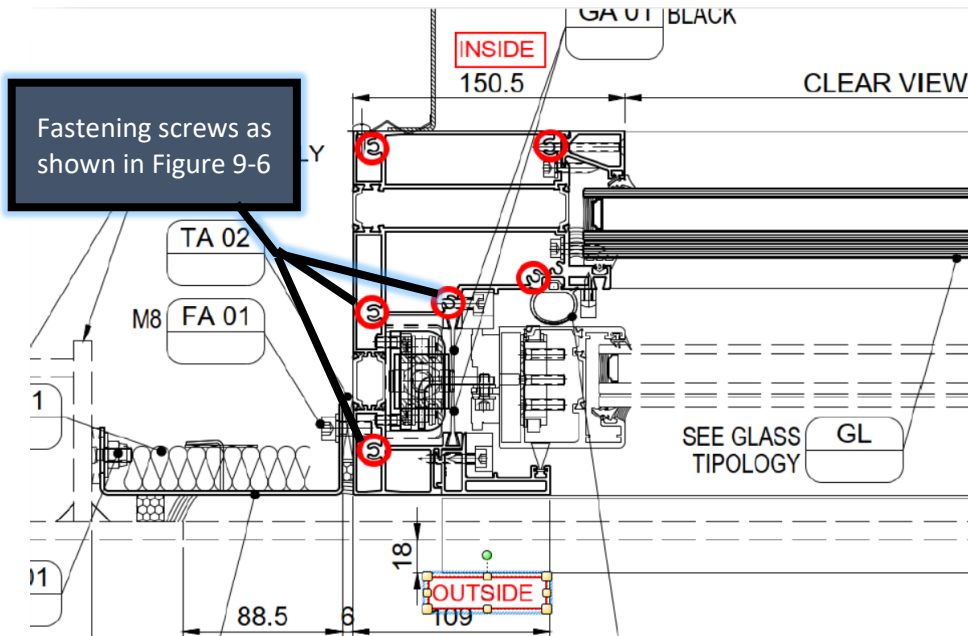
Figure 9-7 Fastening screws for the window frame seen from above
