Issued November 2023

REPORT MARINE 2023/06

***Marine casualty involving the cruise ship
'Viking Polaris' south-east of Cape Horn,
29 November 2022***

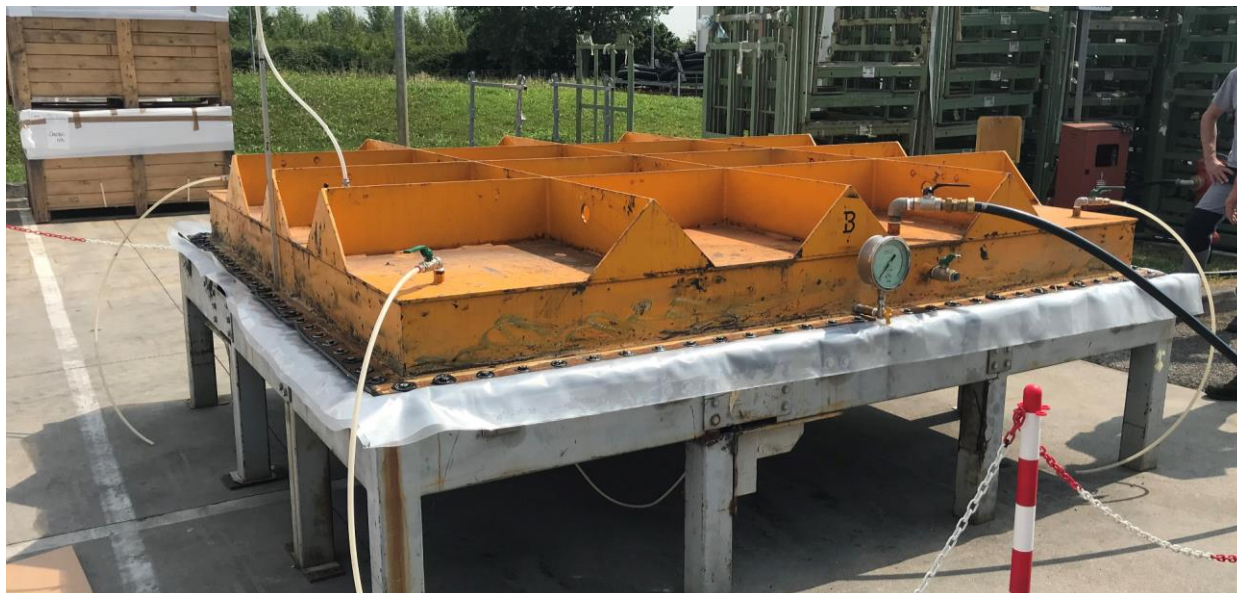
The test was performed in accordance with the ship rules Pt. 3 Ch. 12 Sec 6 [6.2] items 1–3. The test was performed on a hydrostatic test bench by statically applying the design pressure (35.4 kPa) over a period of 5 minutes. This corresponded to the design pressure of the forward window in stateroom 2000, which was also the strongest on deck 2. Figure 10-1 shows a photo from the test.

SOMEK has, on its own initiative, increased the pressure applied during the test to 40 kPa in order to test the windows' residual capacity [10]. The test was positive, as no visible damage or deformations were registered.

Figure 10-1 Static pressure test. Photo from window manufacturer SOMEK

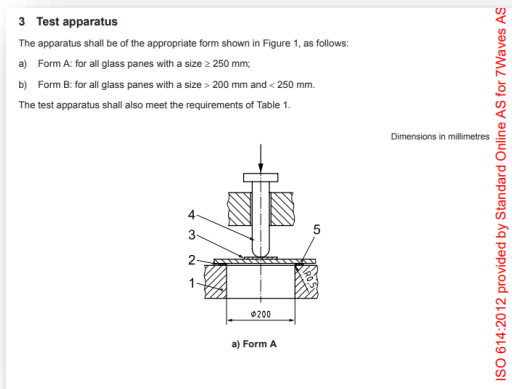
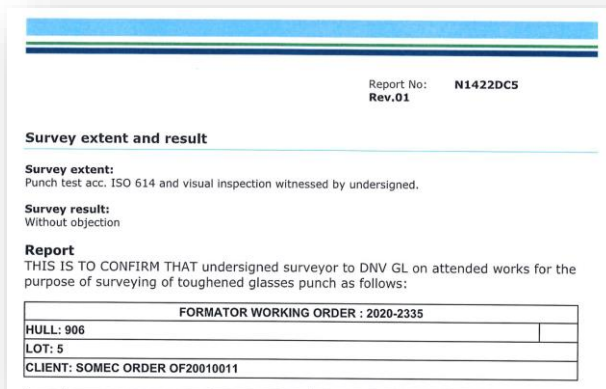
A punch test has been performed in accordance with ISO 614. This test is relevant for toughened safety glass used for ship windows, and checks the local strength of the glass. The test is performed by placing a piece of glass over a flat ring. A punch is then placed over the centre of the flat ring. Finally, the punch is pressed against the glass to a specified design force to test its local strength. The force increases by 1 kN/s [12]. The test was approved and is documented in [10].

Figure 10-3 Details from the punch test

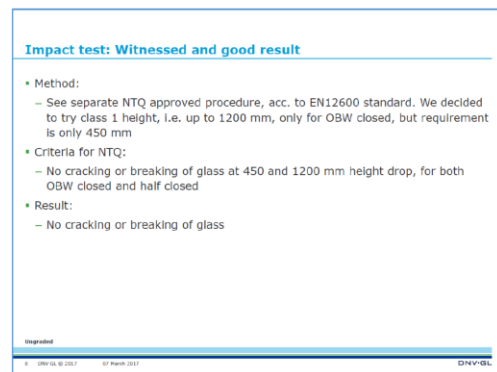
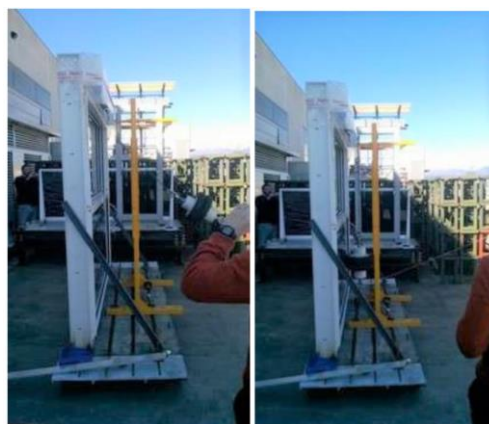
An impact test has been performed in accordance with EN 12600 using a 50 kg impactor and a drop height of 1.2 m. Details about the test are documented in [14]. The requirements for the test are described in the ship rules [6], Pt. 5 Ch. 4 Sec. 1 [5.1.5] and are relevant for glass balcony railings. These windows become like balcony railings in the lowered position. The test was approved and is documented in [15].

IMPACT TEST: Somek followed the standard described in the European Norm EN ISO 12600, with an impactor of 50 kg. Specification asked for a drop height of 450 mm. A further test to 1200 mm of drop height was passed, even if not mandatory for the specs.

Figure 10-5 Impact test

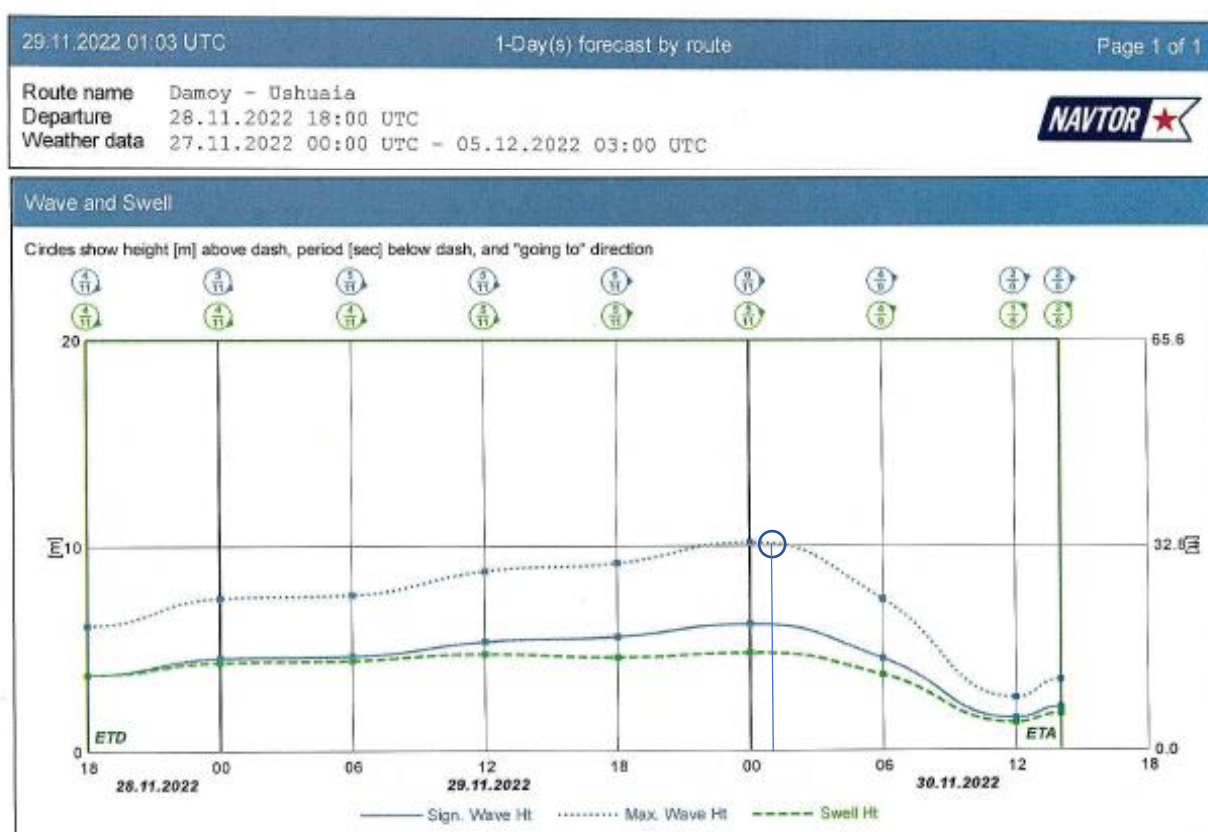
Based on the weather forecast [16], the wave state at the time of the accident was characterised by the following significant and maximum wave height and associated wave period ($H_s = 6$ m, $H_{MAX} = 10$ m, $T_p = 11$ s). Figure 11-1 shows a transcript from the ship's route planning station.

Figure 11-1 Transcript from the ship's route planning station for the voyage Damoy-Ushuaia [16]. The blue circle shows the time when the accident occurred (01:35 UTC)

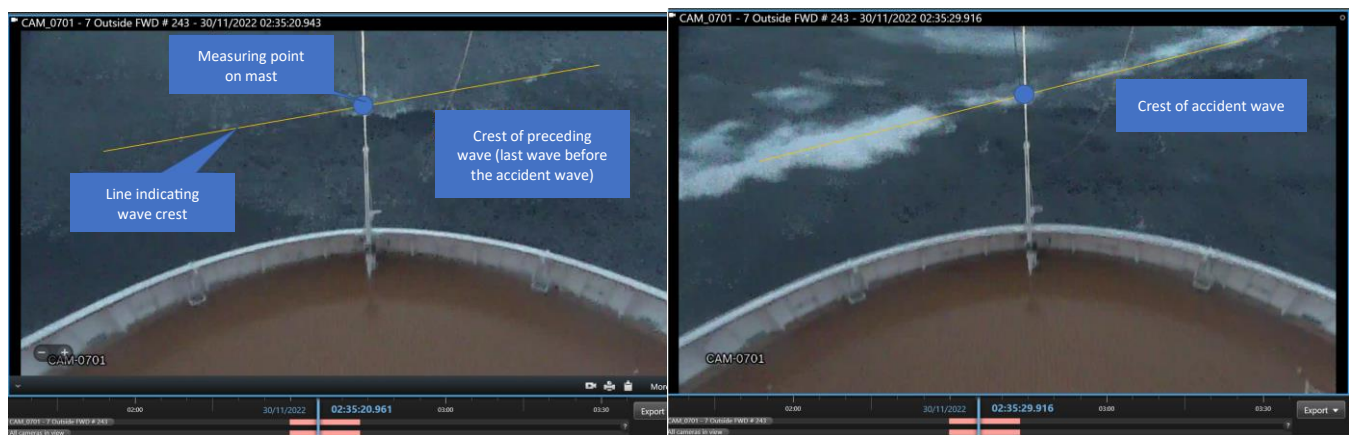
Figure 11-4 CCTV footage from the bridge showing the time interval between the preceding wave and the accident wave, measured from the bow mast.

Figure 11-4 shows the crest of the preceding wave passing approximately at the measuring point of the bow mast at 2:35:20:9 and the crest of the accident wave passing approximately the same point at 2:35:29:9, which gives a wave encounter period of 9.0 seconds.

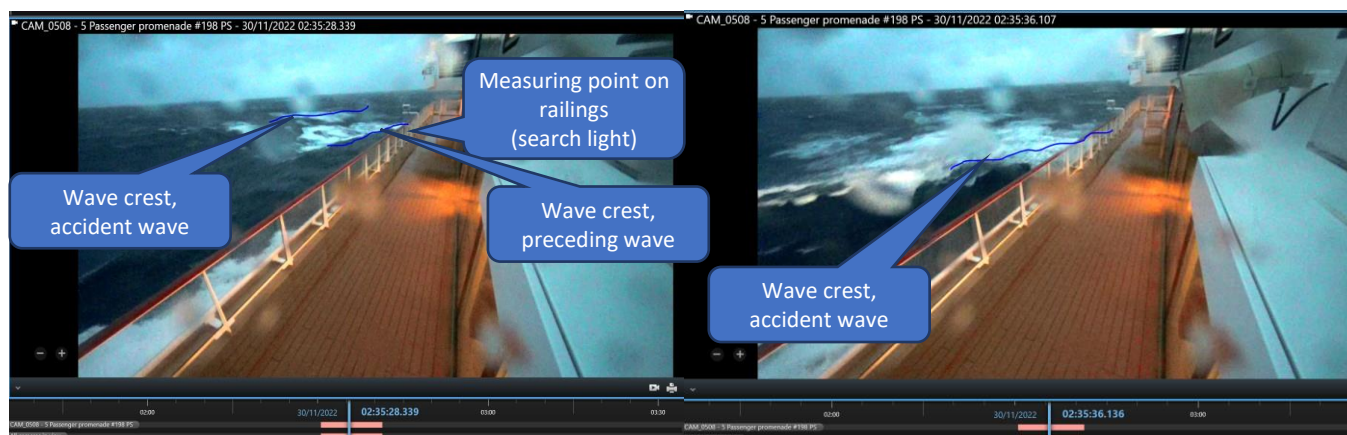
Figure 11-5 CCTV footage from frame #198, deck 5, port side. The measuring point is the search light mounted on the railing.

Figure 11-5 shows the crest of the preceding wave passing the area around the rack at 2:35:28:3 and the crest of the accident wave passing approximately at the measuring point at 2:35:36:1, which gives a wave encounter period of 7.8 seconds.

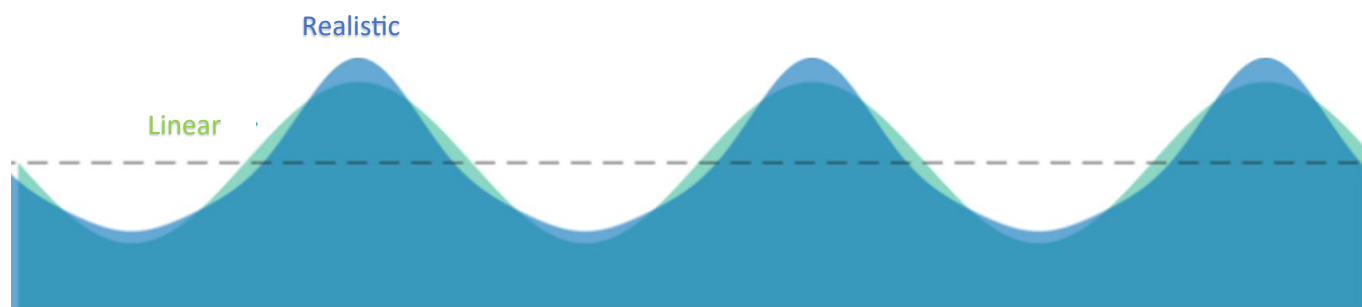
Because of nonlinear effects, some waves have a crest that is higher than their trough is deep, and it can be assumed that the crest is up to 20% higher than the amplitude of a regular wave; see asymmetry factor in [4]. This phenomenon is shown in Figure 11-6, where a linear wave is compared with a realistic (nonlinear) wave.

Based on a crest height of 11 m and an asymmetry factor of 1.2, we can conclude that the size of the accident wave was less than $(11 \text{ m}/1.2 \cdot 2)$ 18.3 m.

Figure 11-6 Comparison of linear and realistic wave. The realistic wave has a higher crest and a shallower trough.

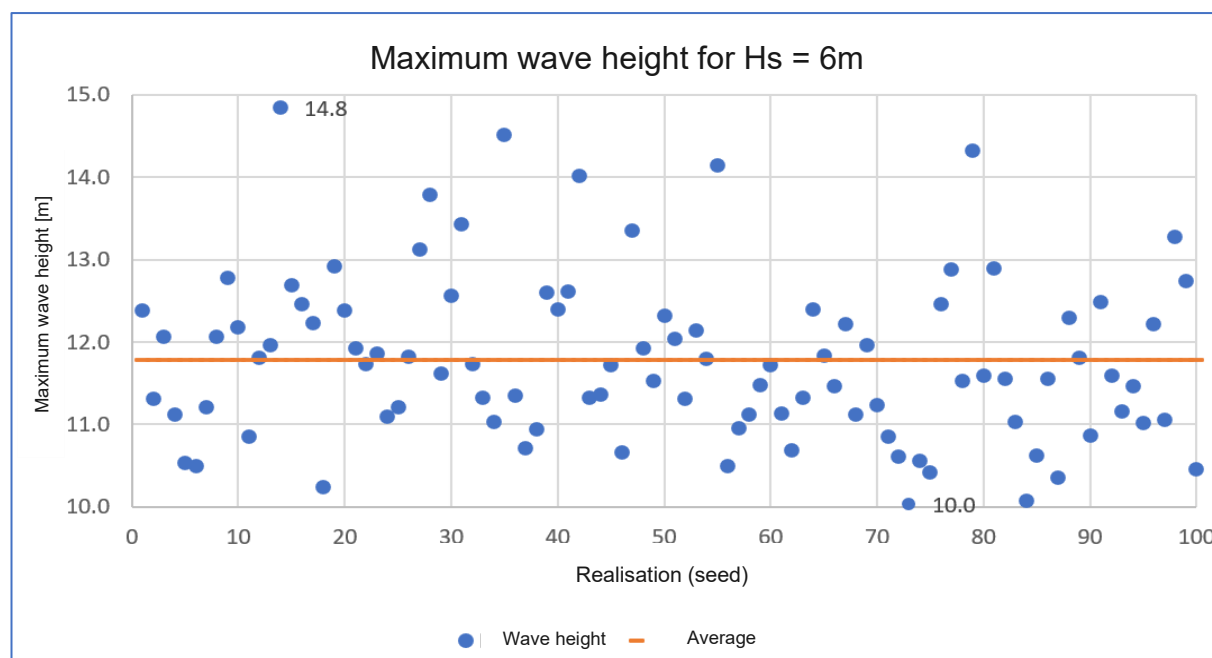
The results of the simulations for $H_s = 6$ m are shown in Figure 11-7. The results of the simulations are given in Table 11-1.

Figure 11-7 Maximum wave height from wave simulations for $H_s = 6$ m
